Feasibility Study for EDR Wastewater Treatment and Recovery

PREPARED FOR: David Gattis/City of Sherman
PREPARED BY: Jennifer Henke/DFW
Jim Lozier/PHX
DATE: January 17, 2001

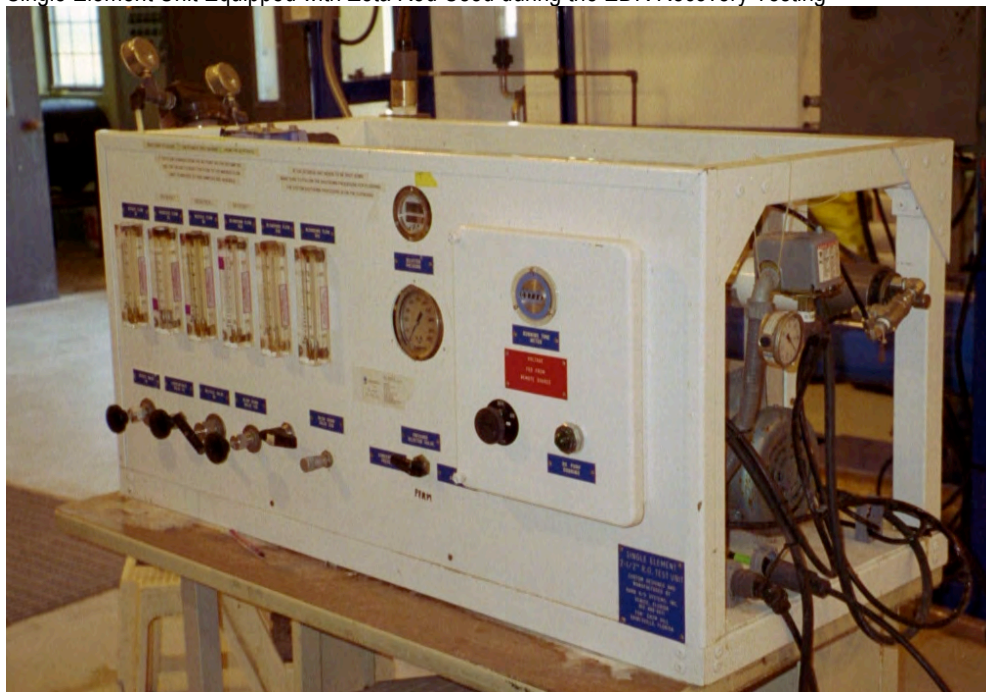
FIGURE 2

EDR wastewater pretreated by the Zeta Rod was then treated using a single element bench-scale RO unit (SETU) provided by CH2M HILL. A photo of the SETU is shown in Figure 2. Major components of the SETU included a cartridge filter, high pressure feed pump, pressure vessel containing one 2.5"-diameter by 40"-long RO spiral wound element, Koch/Fluid Systems model 2540HR thin film composite polyamide type membrane, and flowmeters and pressure gauges. Unlike, the GrahamTek unit, which operates in a single pass mode (feed flow entering the pressure vessel is converted to permeate and concentrate and wasted from the system), the SETU operated in both single pass and concentrate recycle modes (a portion of the concentrate exiting the pressure vessel is recycled back and blended with the incoming feed) depending on feedwater recovery¹. At feedwater recoveries >15%, concentrate recycle was employed. Permeate and waste concentrate flows from the SETU were directed to the EDR wastewater holding pond. When required, the SETU element was chemically cleaned to remove foulants and scalants accumulated during operation. No chemical treatment was applied to the Zeta Rod/RO feedwater.

Single Element Unit Equipped with Zeta Rod Used during the EDR Recovery Testing

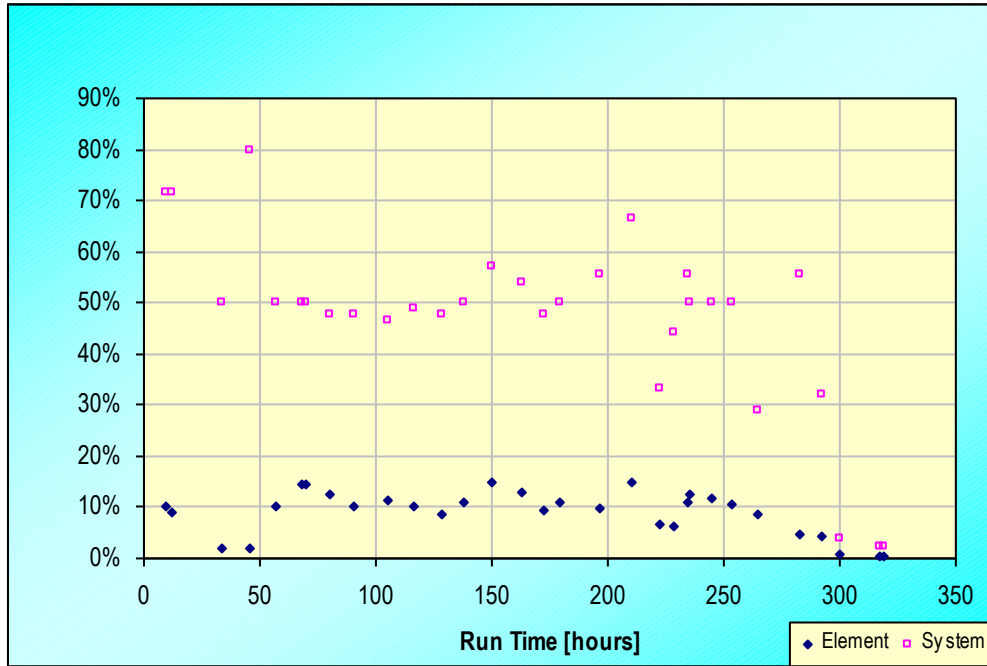
FIGURE 3
Zeta Rod Element No. 1 Feedwater Recovery

Feedwater recovery was consistently maintained at the target value of 50% although some variations did occur. These were associated with the difficulty of adequately controlling the very low waste concentrate flows. Feed pressure was quite stable during the first 250 hours of operation, at which time it increased dramatically. Product water conductivity showed a step increase from 350 to 1,300 uS/cm at ~60 hours. WTC was stable until feed pressure increased at which time it declined rapidly. Likewise, STC changes mirrored those of product water conductivity. The increases in feed pressure and product conductivity and decline in WTC are attributed to unplanned shutdowns and lack of timely feedwater flush associated with valve plugging. Following these uncontrolled shutdowns, supersaturated salts would have an opportunity to precipitate within the feed channels of the element. Based on the results of the autopsy of element No. 1 (see subsequent section titled Element Autopsy), calcium sulfate was the predominant precipitated salt.

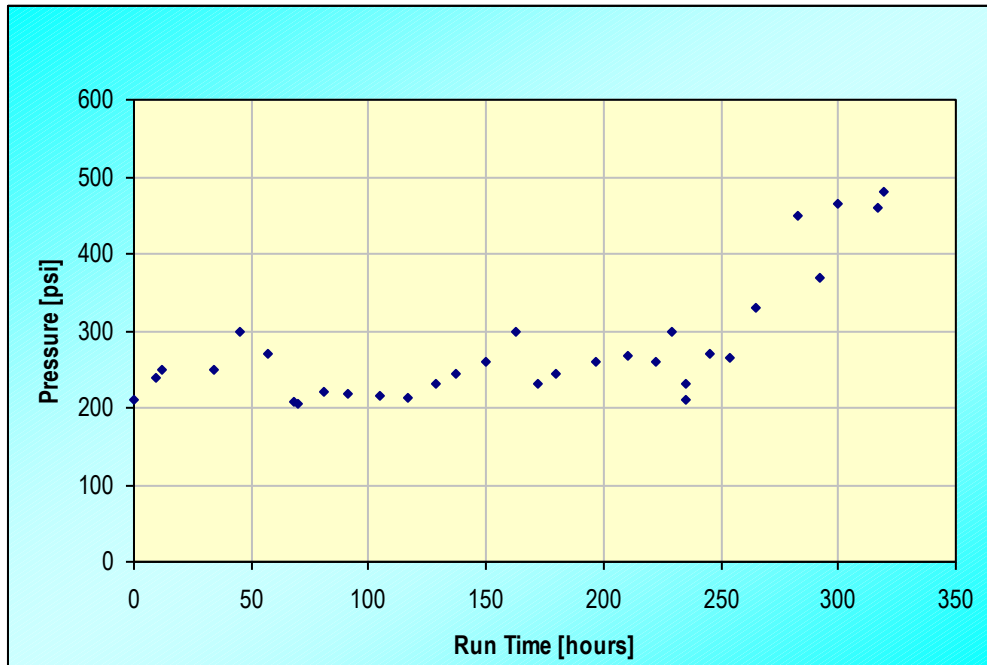
FIGURE 4
Zeta Rod Element No. 1 Feed Pressure

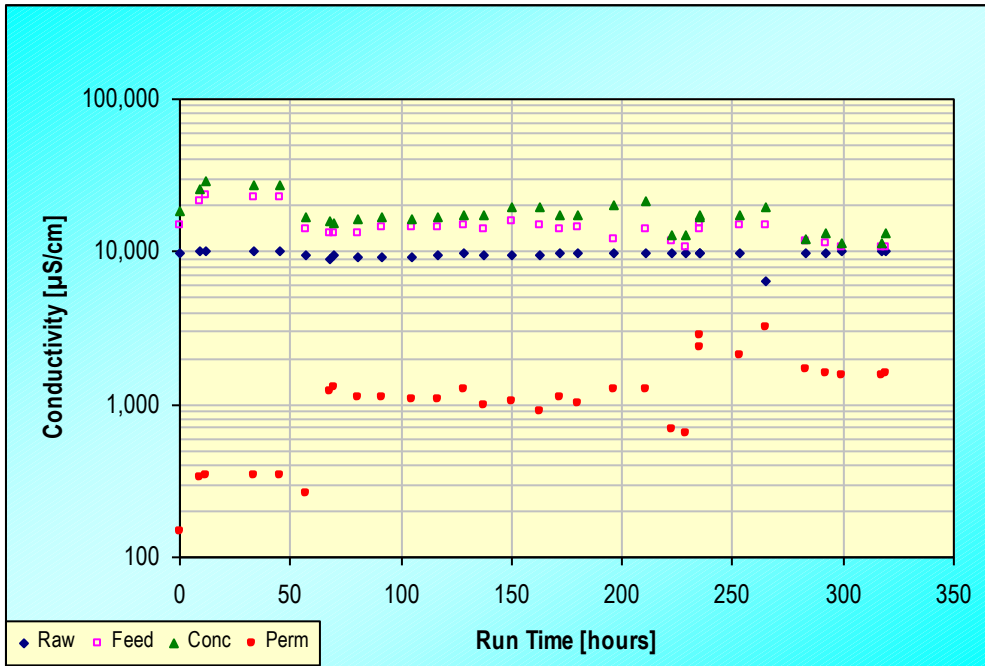
FIGURE 5
Zeta Rod Element No. 1 Feed and Permeate Conductivities

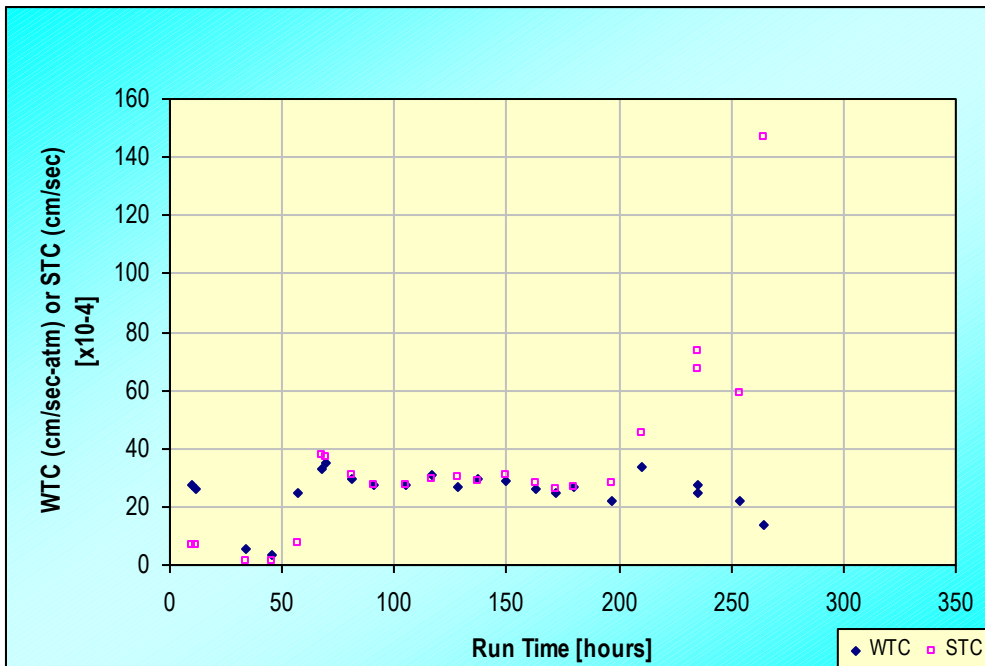
FIGURE 6
Zeta Rod Element No. 1 Water and Salt Transport Coefficients

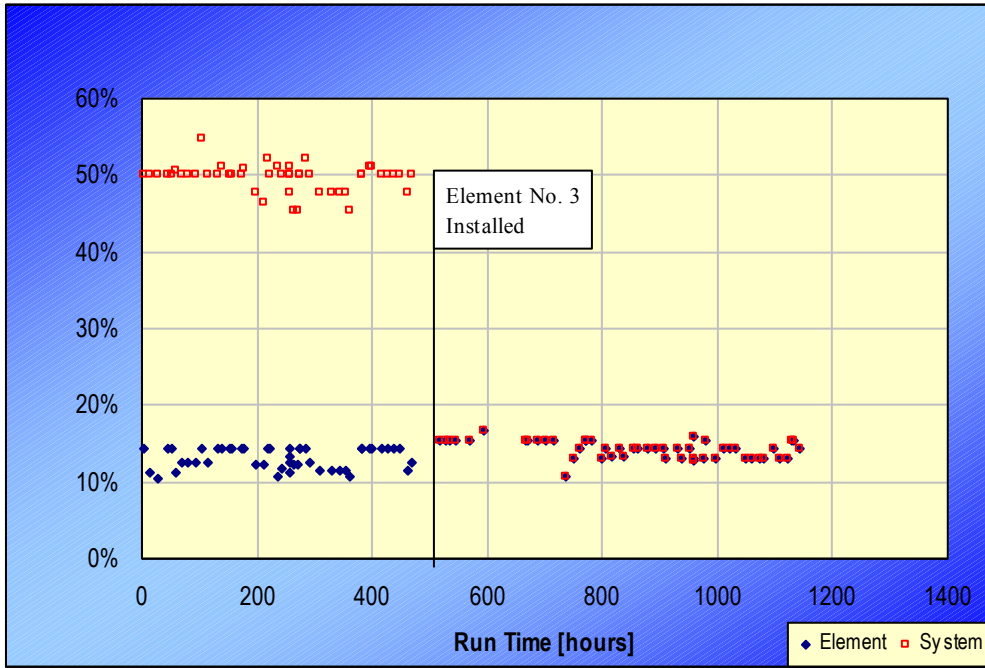
FIGURE 7
Zeta Rod Element Nos. 2 and 3 Feedwater Recovery

In contrast to that of element No. 1, the performance of element No. 2 showed no period of stability. Feed pressure and permeate conductivity increased and WTC decreased steadily from start-up through the end of testing. No autopsy was performed with this element to determine if precipitated salts were accumulating at the feed end the element (like element No. 1), however ΔP was stable during the entire period of operation. This indirectly indicates that any salt buildup was minor. The cartridge filters did show a pressure drop increase indicating retention of particulate material. It may be more likely that the performance declines resulted from precipitation of sparingly soluble salts from concentration at the membrane surface (which would be more noticeable at the concentrate end), chemical oxidation of the membrane, or a combination.

Element No. 3 performance was stable for the first 320 hours at which time, feed pressure increased and WTC declined steadily. Product water conductivity did increase during this latter period of operation but at a much lower rate and to a much lesser extent than for element No. 2. Further, chemical cleaning was successful in reducing feed pressure and increasing WTC (see step change at 960 hours run time) but not the increase in product water conductivity. These changes indicate that fouling, rather than scaling was causing the decrease in WTC, but oxidation was responsible for the conductivity increase. Following the cleaning, the element exhibited the same rate of fouling as prior.

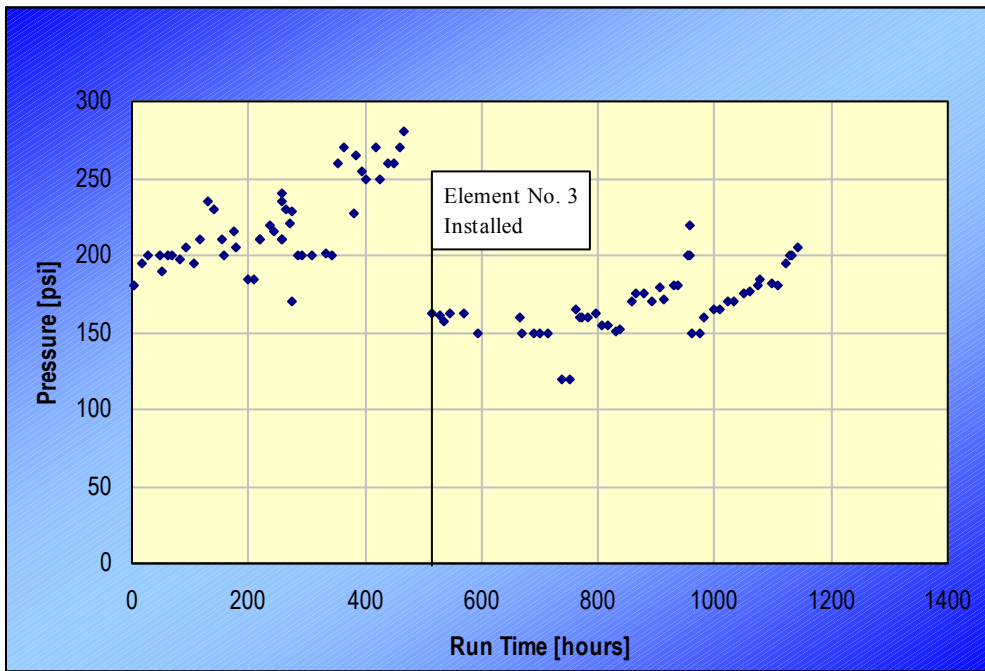
FIGURE 8
Zeta Rod Element Nos. 2 and 3 Feed Pressure

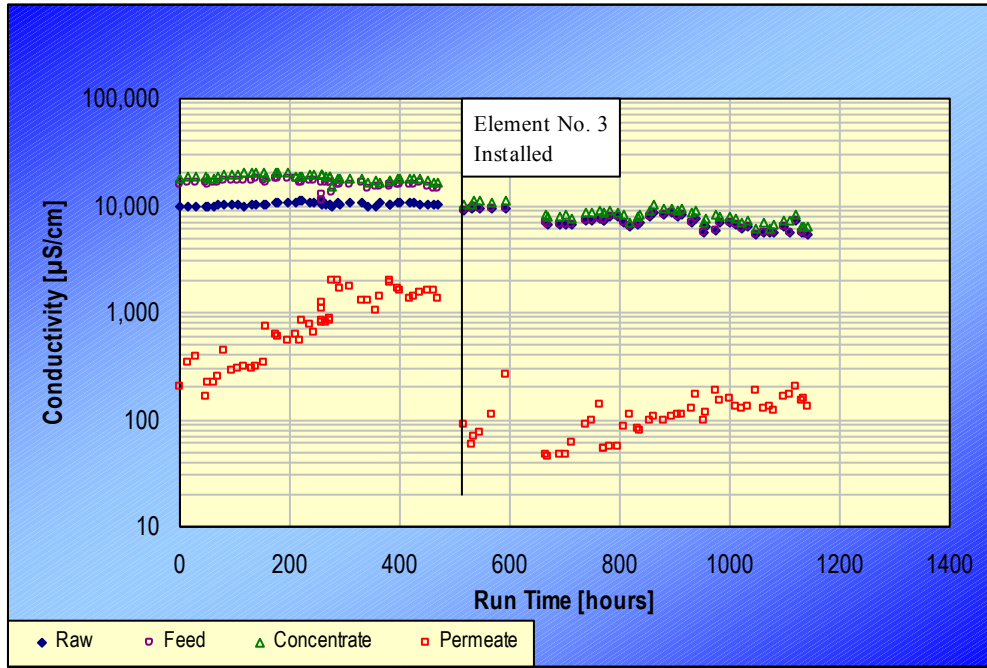
FIGURE 9
Zeta Rod Element Nos. 2 and 3 Feed and Permeate Conductivities

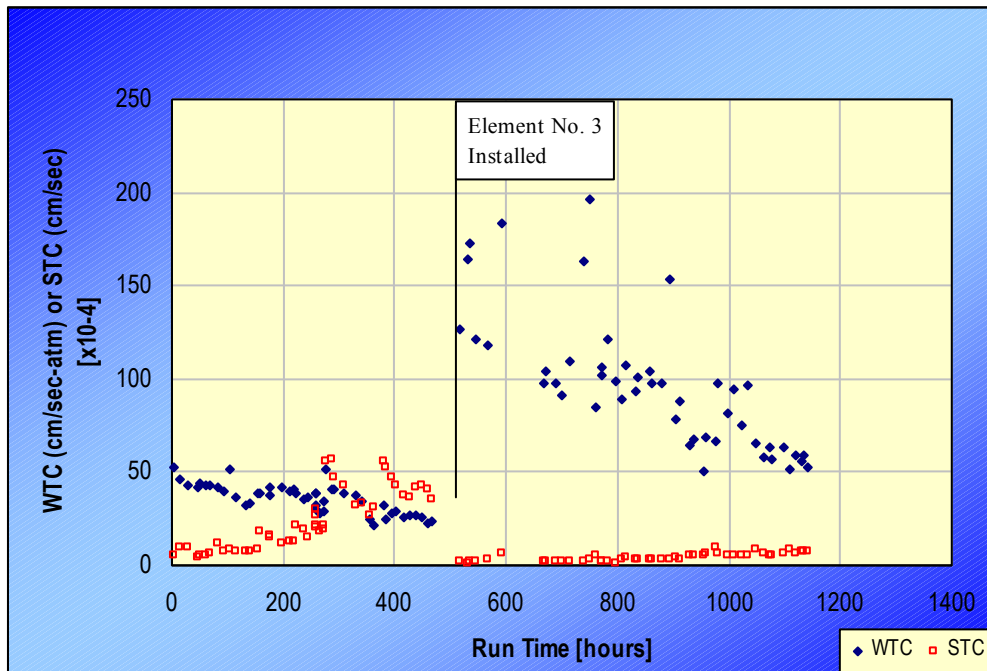
FIGURE 10
Zeta Rod Element Nos. 2 and 3 Water and Salt Transport Coefficients

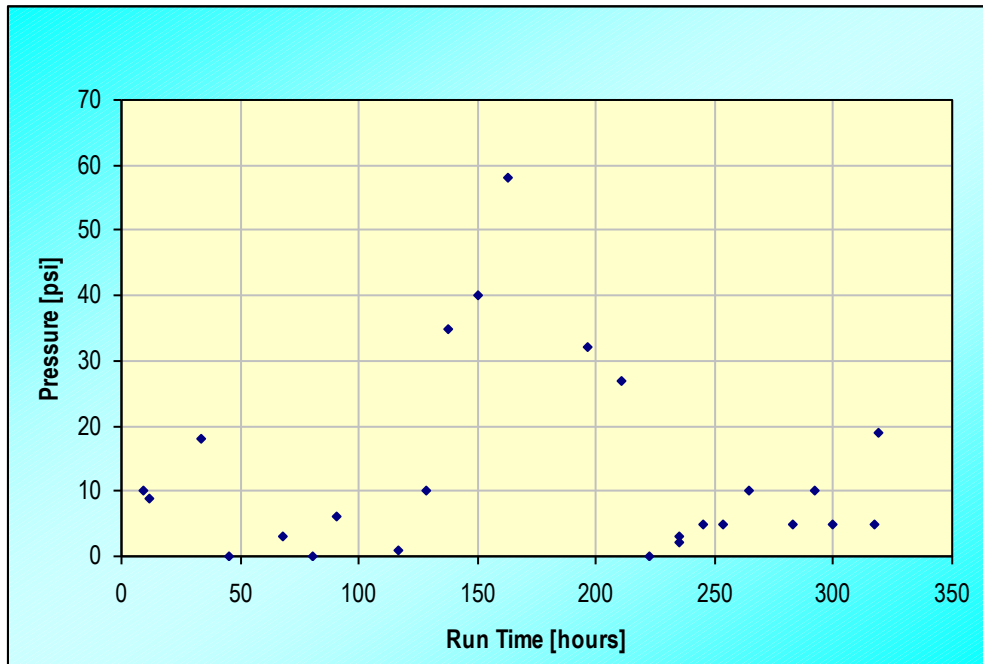
FIGURE 11
Zeta Rod Element No. 1 Differential Pressure

The BORERC staff postulated that four salts, barium sulfate, calcium sulfate, strontium sulfate and calcium carbonate, were supersaturated in the element feed. The degree of supersaturation was not above that allowed with the use of a scale inhibitor, however. At 50% recovery, the calcium sulfate was estimated to about 2.2 times saturation in the concentrate. This degree of supersaturation could have caused calcium sulfate to precipitate in the concentrate recycle loop. Three alternatives are possible to explain the presence of precipitated salts in the element: (1) the salts present in the water held in the element precipitated when the RO unit was shut down and the supersaturated feed / concentrate solution was not flushed prior to element removal and draining, (2) precipitation occurred during or after EDR treatment or (3) precipitation occurred in the concentrate recycle loop. Alternative (1) is not feasible as it would produce a precipitation pattern different from that observed from the autopsy and could not produce the mass of salt collected.³ There is no way of knowing whether alternative (2) or (3) was the cause, however alternative (3) is more likely given the higher concentration of calcium sulfate in this stream. It should be noted that the ΔP did increase from 5 to 10 psi to 30 to 40 psi near the latter period of testing, consistent with the BORERC's conclusion (see Figure 11).

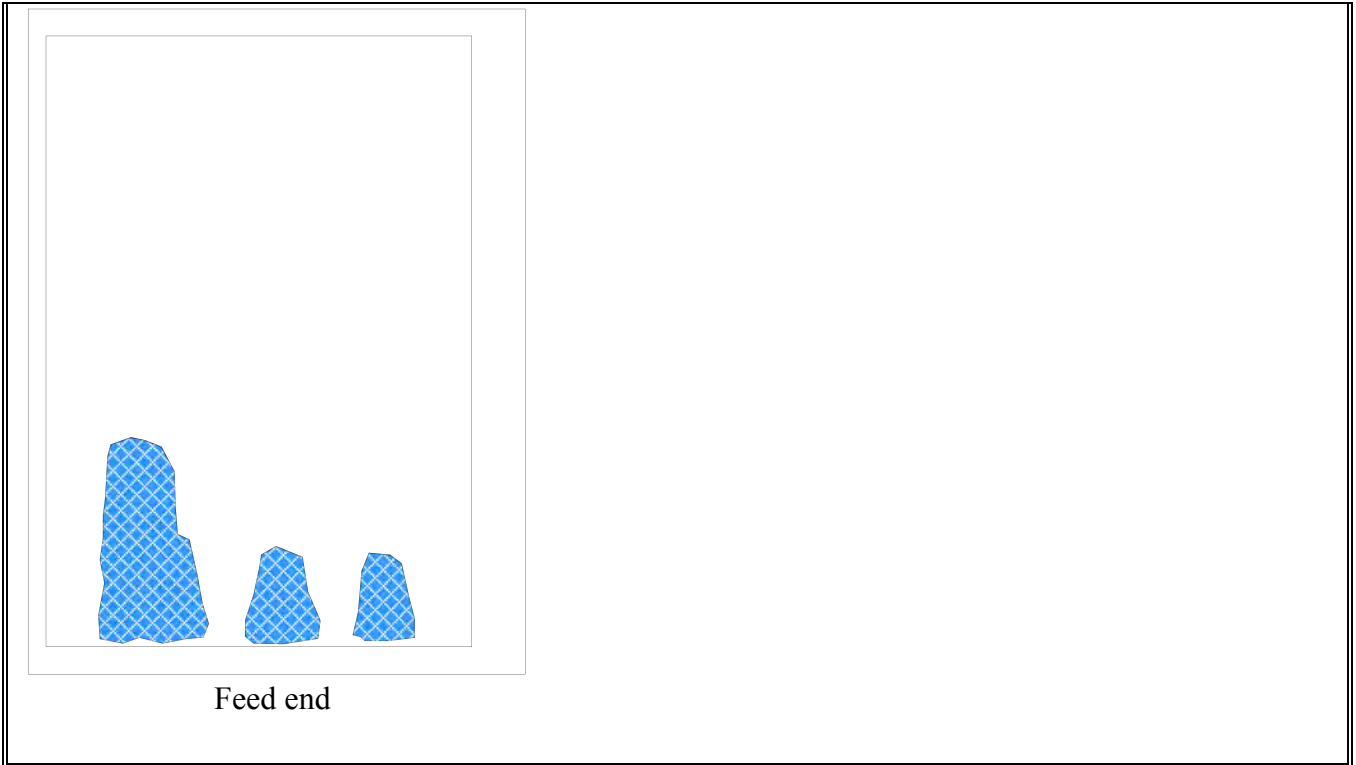
When Leaf 1 was unrolled, heavy deposits of salt were found along the feed end of the leaf. The salt was not evenly distributed across the leaf but was concentrated across what we believe was the feed end of the leaves. Where there was a deposit, it appeared to be almost solid from one membrane surface through the vexar to the other leaf. The solidity of the deposit is uncertain visually since salt stuck to the membrane surfaces and thus broke into several layers, one on each membrane, with a modest amount still adhering to the vexar. The deposition appeared to be only on the active area, starting essentially at the downstream edge of the glue line on the feed end. While it is not possible to say that the distribution of salt that we saw was not influenced by the process of unrolling the element leaf, it appears that even across the entrance to the leaf, the salt was not evenly distributed. There was a region 3 to 4 inches from the product water tube where there was no deposit. Further out into the element, measured from the tube, was the heaviest deposit, which extended some 11 to 12 inches from the feed end.

In places, salt appeared to fill the voids in the vexar completely. The sketch below shows the location of heavy salt deposits. The outer rectangle represents the outer edges of the leaf; the inner rectangle represents the edge of the active area. The cross-hatched areas represent the salt deposits.

Reject or concentrate end

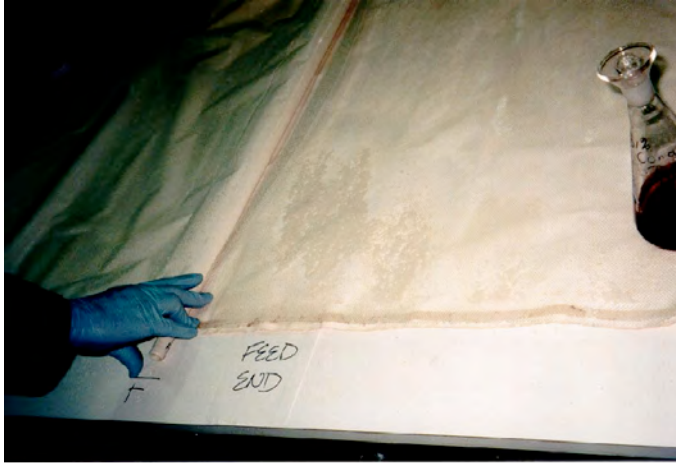
Figure 1. View of concave side of Leaf 2 (on right) and convex side of Leaf 1 (on left). Product water tube runs from lower left to top center. The feed end of the leaf is at the bottom (as marked on the autopsy table). The vexar netting lies on top of Leaf 2. The darker beige blotches are the accumulations of salt on the leaf.

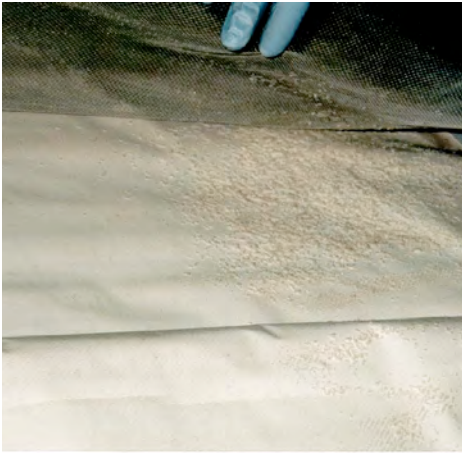
Figure 2. View of vexar being lifted from the concave side of Leaf 2. The crease on the left side of the photo is the membrane crease that separates Leaf 1 (left side of photo) from Leaf 2 (right side). The preference for the salt to adhere to the membrane can be seen from the large fraction of salt that remains on the membrane while comparatively little sticks to the vexar. Salt can also be seen on the convex side of Leaf 1
