## success story

### Manufacturing Solutions reduces chemical and filtration costs GMPT Flint, Michigan USA

#### SUMMARY

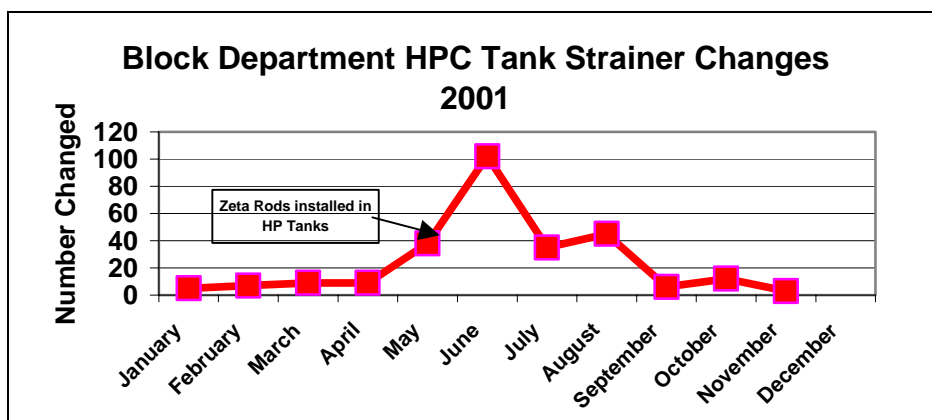
High-Pressure Tank Results

As the following chart indicates, after the installation of Zeta Rods™, there was some increased activity in cleaning of high-pressure tanks as the fungal material began falling off the tank walls. Two weeks after the installation a decision was made to remove the suction strainers from 90% of the high-pressure tanks because fungus was no longer growing at the top of the tanks. The instances of down time due to high-pressure tanks dropped considerably during the subsequent months.

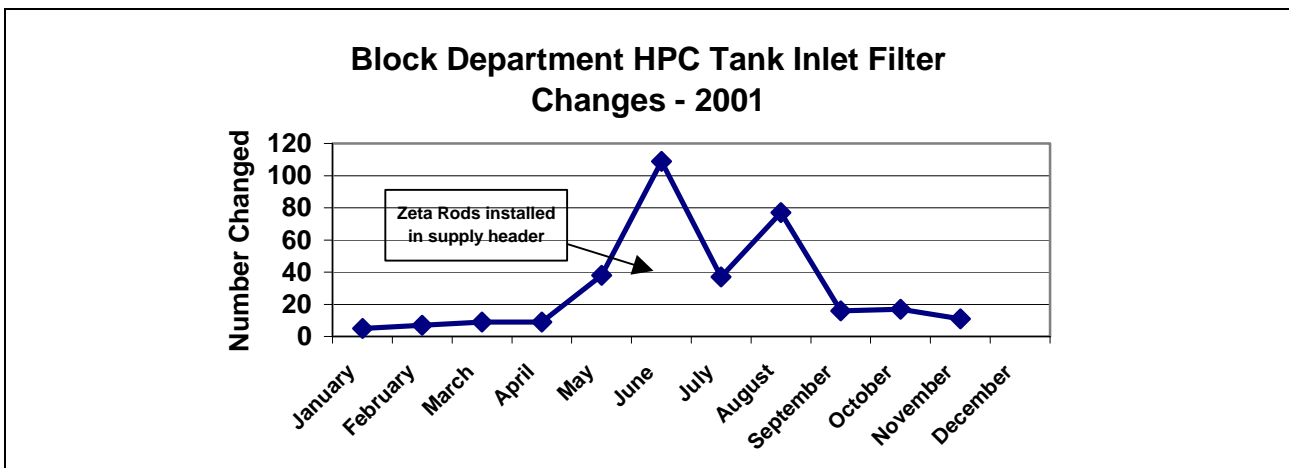
Results of Installation in Coolant Supply Headers

Following the installation of Zeta Rods™ in the high-pressure tanks, it was decided to install additional rods in the main coolant supply header. The installation took place on June 9<sup>th</sup> & 10<sup>th</sup> 2001 and they were activated on June 11, 2001.

Documentation of incidents of inlet filter problems showed a dramatic increase during the 72 hours following installation (It should be noted that additions of fungicide were made to the system a few days prior to activation of the Zeta Rods™). The plugging of inlet filters lasted approximately a week following the installation of the Zeta Rods™ and then returned to normal. (See following chart).
