Demonstration of Noncorrosive, Capacitance-Based Water-Treatment Technology for Chilled-Water Cooling Systems

Final Report on Project F09-AR08

September 2014

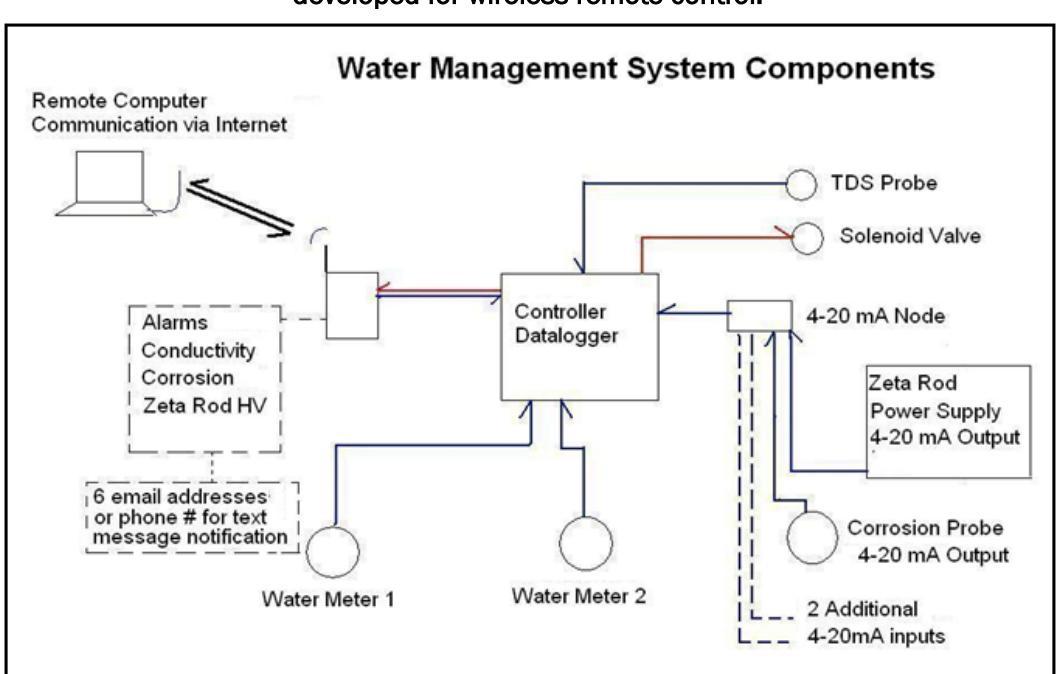
Figure 1. Water-management system components developed for wireless remote control.

Figure 1 shows the system inputs and outputs.

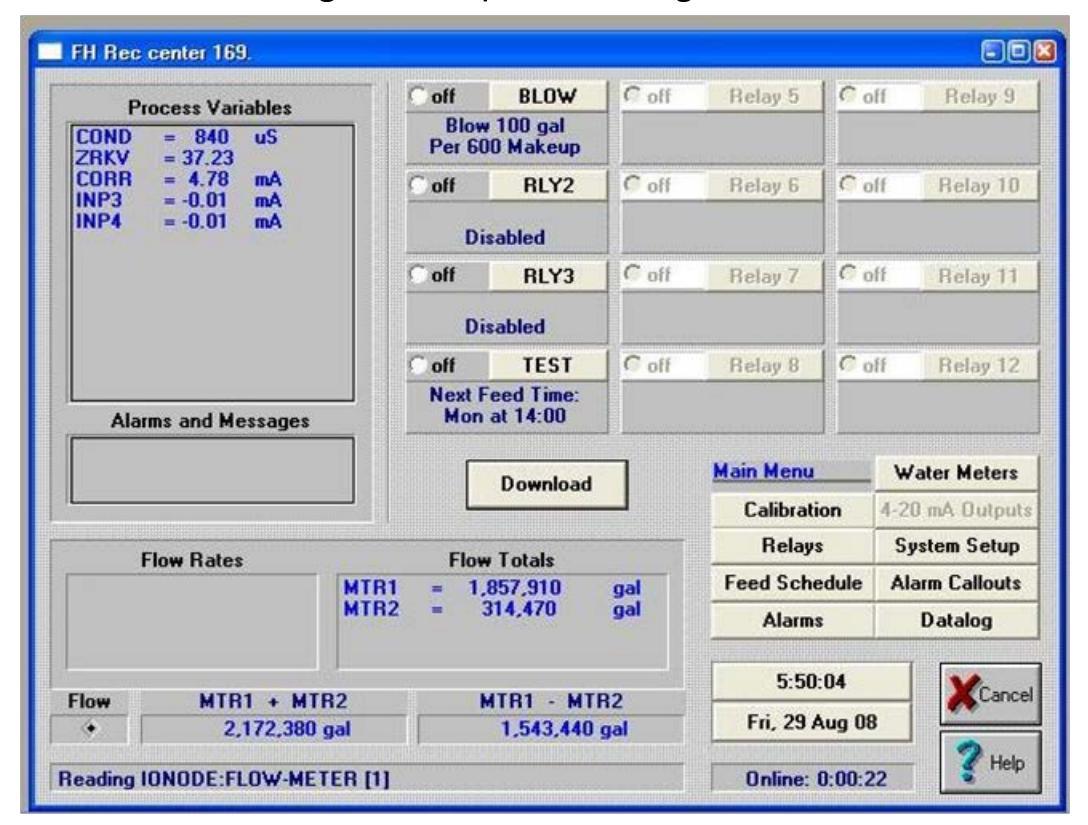
Figure 2. Example of monitoring screen.

Real-time monitoring was accomplished via web connection to the data controller and software, which allowed system adjustments to be made remotely. The control and monitoring components were installed at all four evaporative cooler sites, but not on the swamp cooler sites . Monitoring for pH was included at Warner Robins AFB due to the potentially corrosive nature of the feed water. Figure 2 shows the remote monitoring and control screen as displayed by the monitoring software.

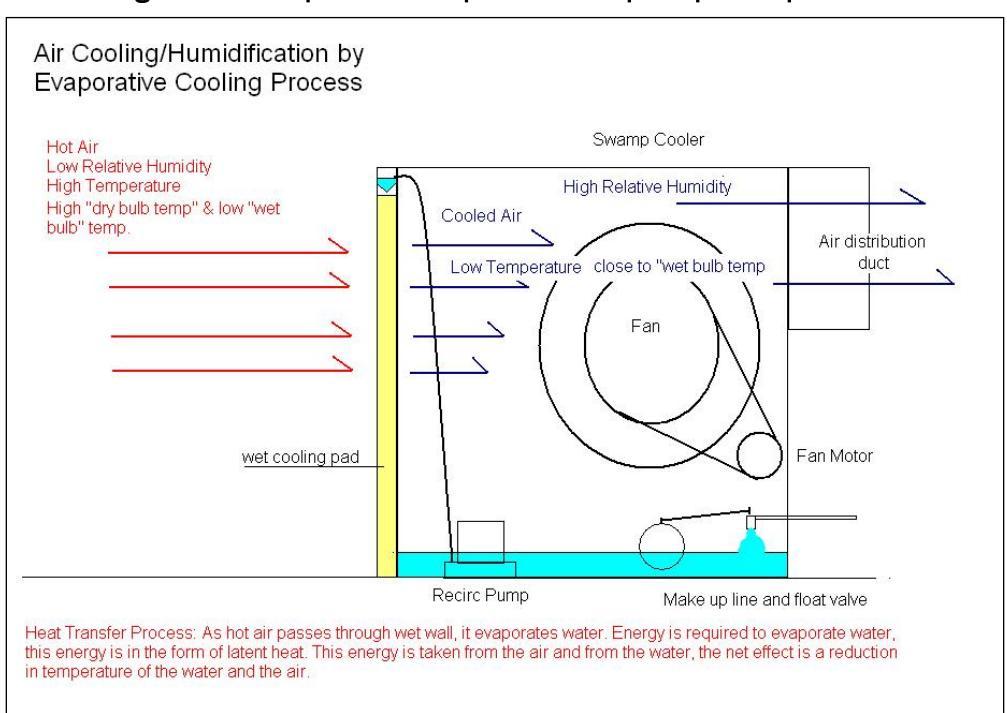
Figure 3. Swamp cooler components and principle of operation.

For the swamp cooler applications, two buildings at Fort Huachuca and two at Fort Irwin, each with similar evaporative coolers were selected. (Figure 4 shows a basic schematic drawing of a typical swamp cooler, including the cooling pad that was weighed as part of Zeta Rod performance evaluation.) The demonstration technology was installed on one building at each base on the main water line feeding the entire building. Selected cooling units on each roof were equipped with preweighed cooling pads. The pads were removed on 60–90 day intervals, then dried and reweighed. The coolers were also equipped with water meters to monitor water consumption, and they were photographed to document mineral accumulation.

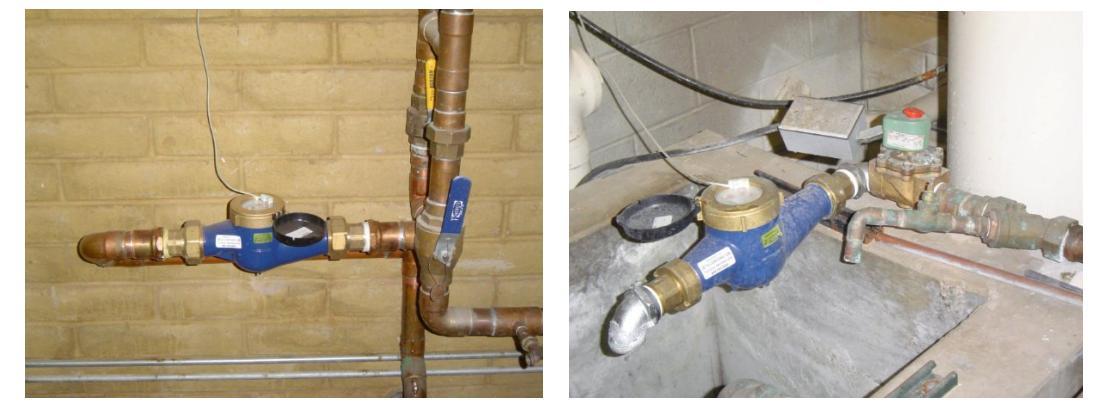
Figure 6. Two-inch water meters in makeup water line (left) and blowdown water line (right) at Fort Huachuca SCP.

Conventional plumbing practices were used for the installation of the 2 in. water meters. Figure 6 indicates the water meters on the makeup (MU) water line and blowdown (BD) water line respectively.

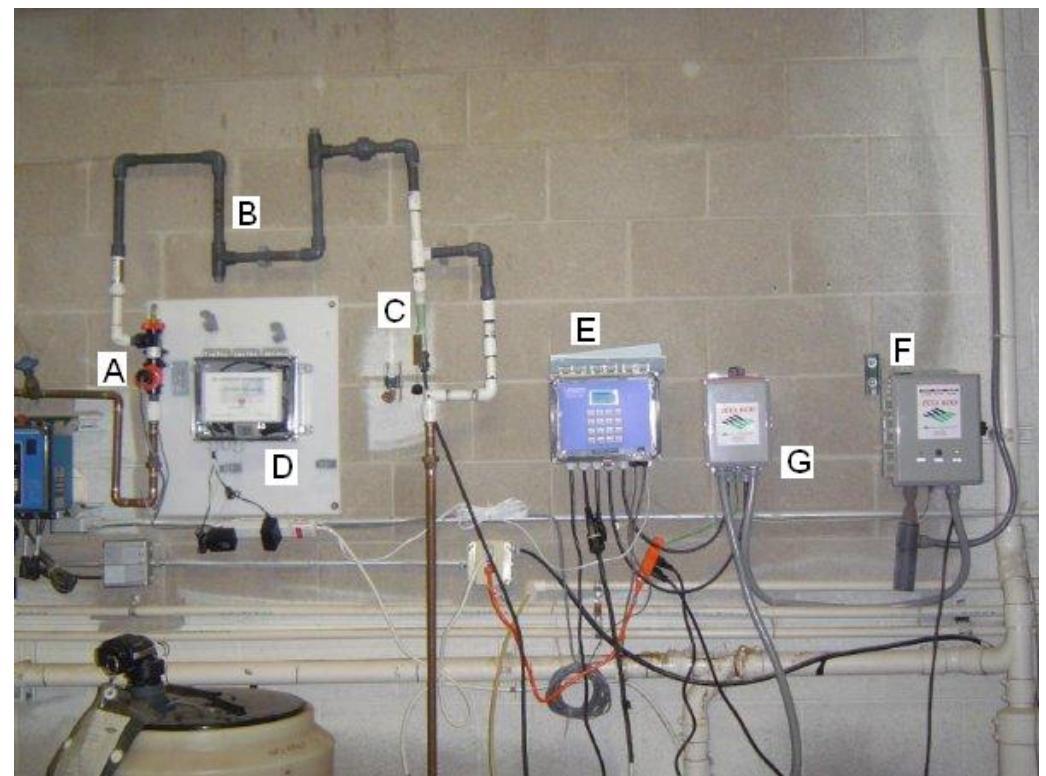
Figure 7. Water-management system components.

Figure 7 shows all the hardware used in the water-management system.

Reading from Figure 7, the components are (A) conductivity sensor and flow switch plumbing assembly; (B) pressure flow regulator and corrosion coupon rack; (C) electronic corrosion probe; (D) wireless communications hardware; (E) controller/data logger; (F) power supply for capacitor; and (G) enclosure for corrosion probe transmitter power supply (transmitter not shown).

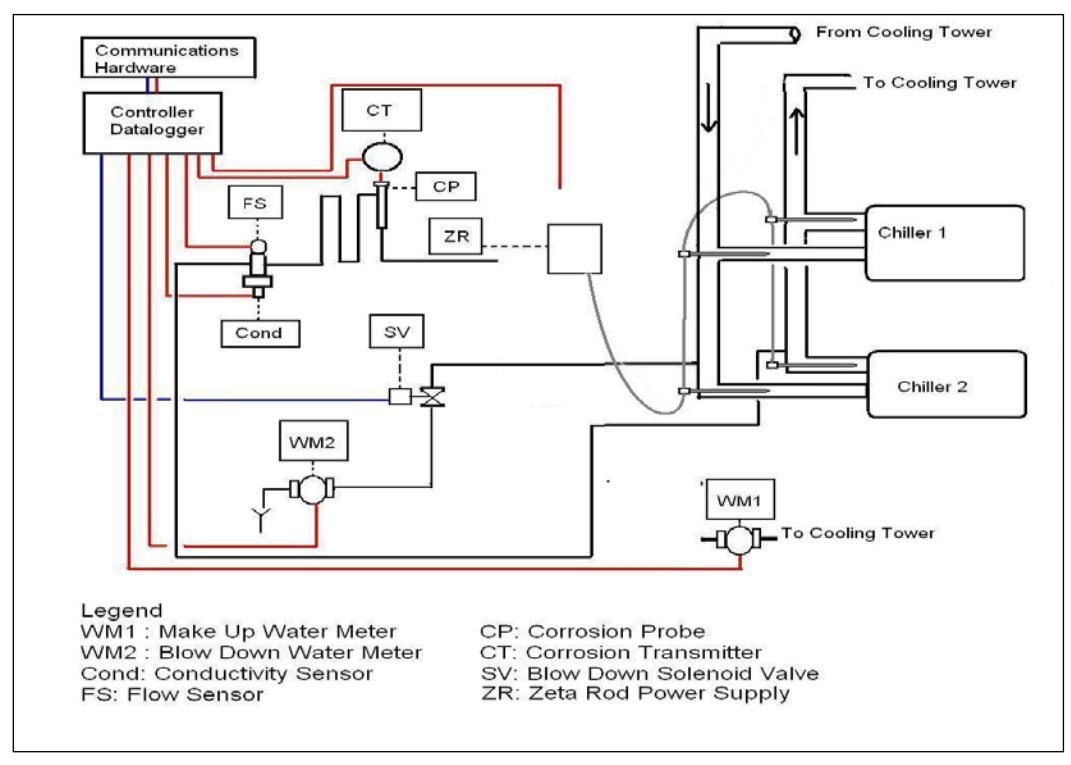
Figure 8. Components of Zeta system at Fort Huachuca SCP.

Figure 8 shows the components of the demonstrated water-treatment system installed at the South Central Plant.

The volumetric ratio cycle control was programmed at 400 gallons of blowdown for every 2,000 gallons of makeup (2,000/400 = 5 cycles of concentration).

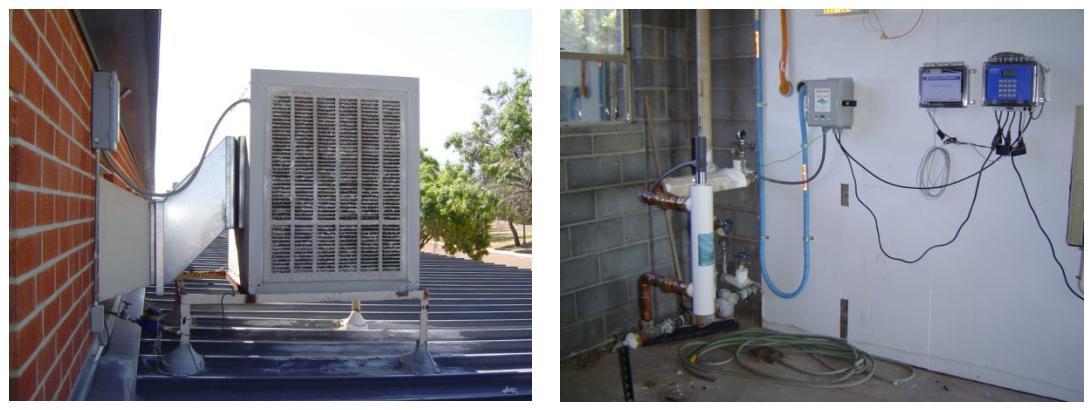
Figure 9. Swamp coolers and Zeta system components in Building 52110.

A capacitance-based treatment system consisting of a ZR18S Zeta Rod, ZR200S stainless steel chamber and ZRPGM power supply were installed into the 2 in. main water line feeding the building. A controller/datalogger was installed in the room and set to continuously monitor the high voltage (HV) output of the power supply through a 4 - 20 milliamp (mA) circuit and programmed to send an alarm if the signal dropped below 10 mA. Figure 9 shows the Zeta system installed in the main water line feeding the building as well as one of the swamp coolers mounted on the roof of the building.

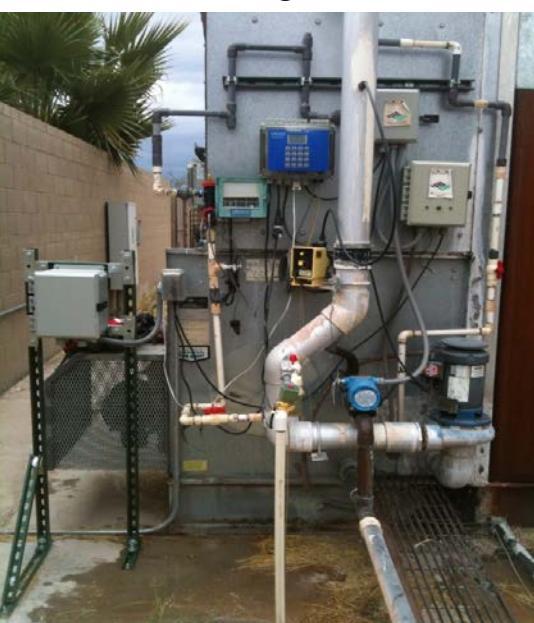
Figure 11. Zeta equipment mounted on evaporative condenser at Davis-Monthan Building 2301, Fitness Center.

The equipment at this location, installed for the 2007 CRADA dem/val (Figure 11) was inspected for proper operation and for calibration.

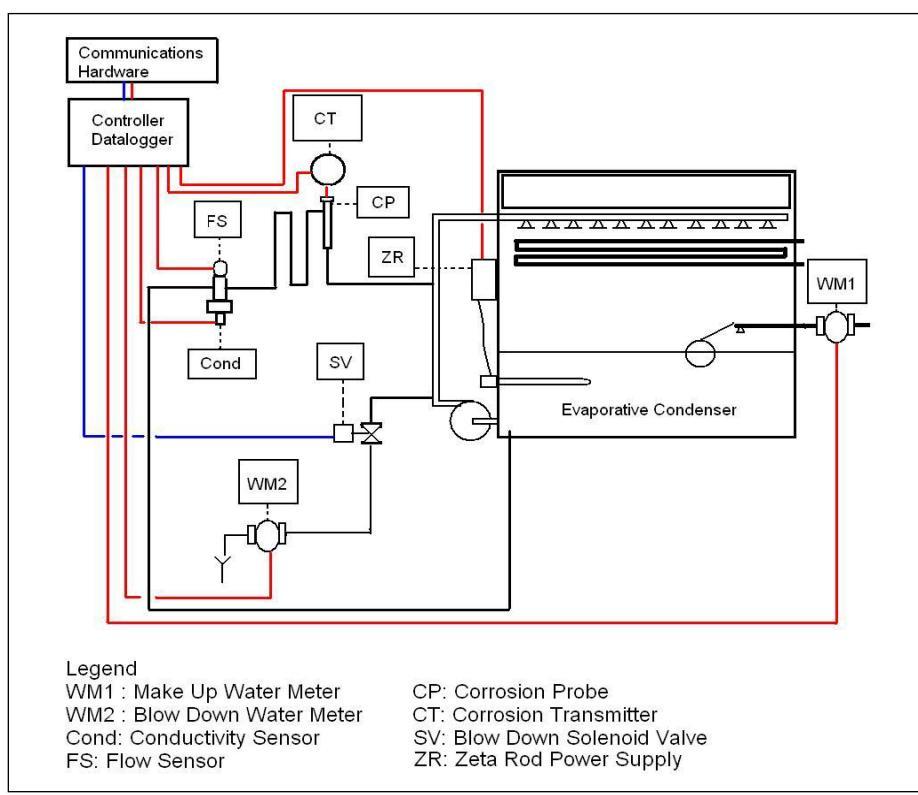
Figure 12. Equipment layout Building 2301 Zeta application.

Figure 12 shows the layout of the equipment installed at this location.

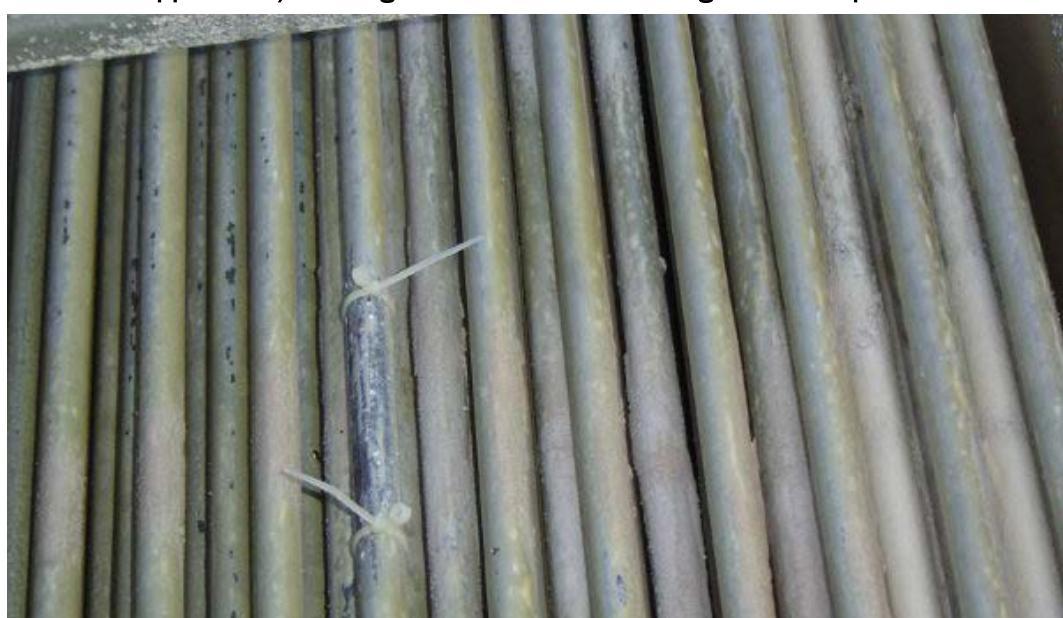
Figure 13. Evaporative condenser tube bundle at Building 2301 (Zeta Rod application) showing section of cleaned tubing between zip ties.

The condenser tubes were photographed to record their condition. One tube had been previously cleaned and tagged with zip-ties to serve as a coupon to evaluate the formation of new deposits (Figure 13).

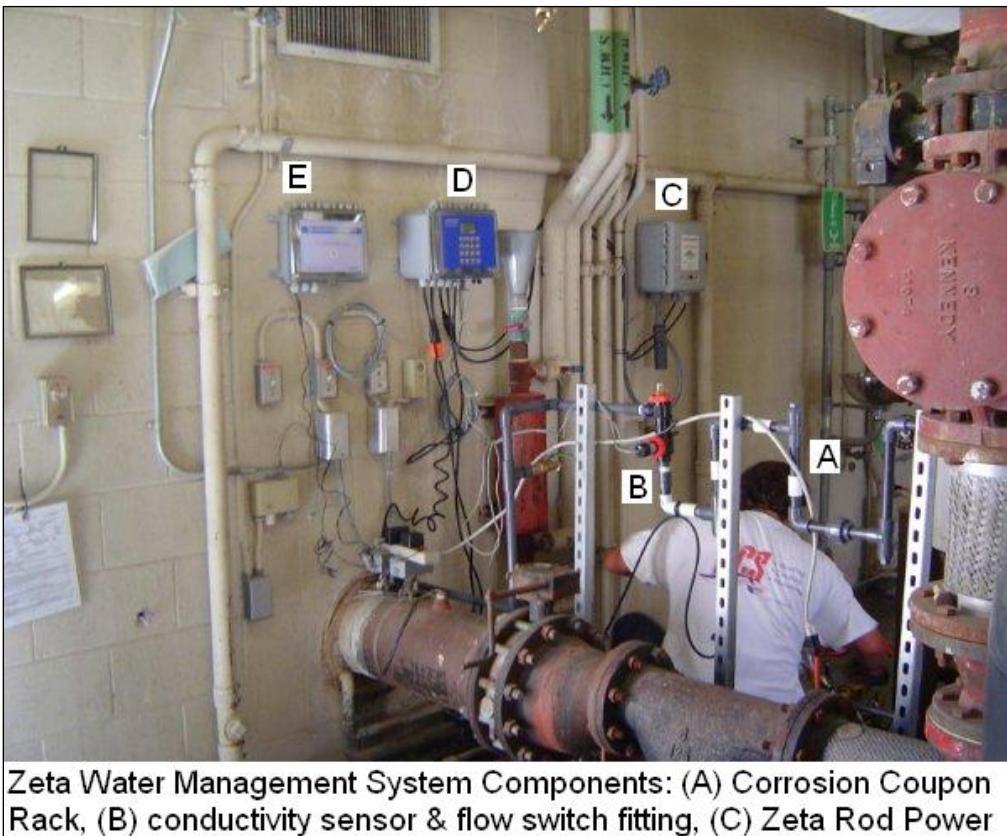
Figure 15. Components of the water-management system in Fort Irwin Building 263.

Figure 15 shows the components of the water-management system installed at this location.

Zeta Water Management System Components: (A) Corrosion Coupon Rack, (B) conductivity sensor & flow switch fitting, (C) Zeta Rod Power Supply, (D) Controller/Datalogger, (E) Wireless Communications Hardware

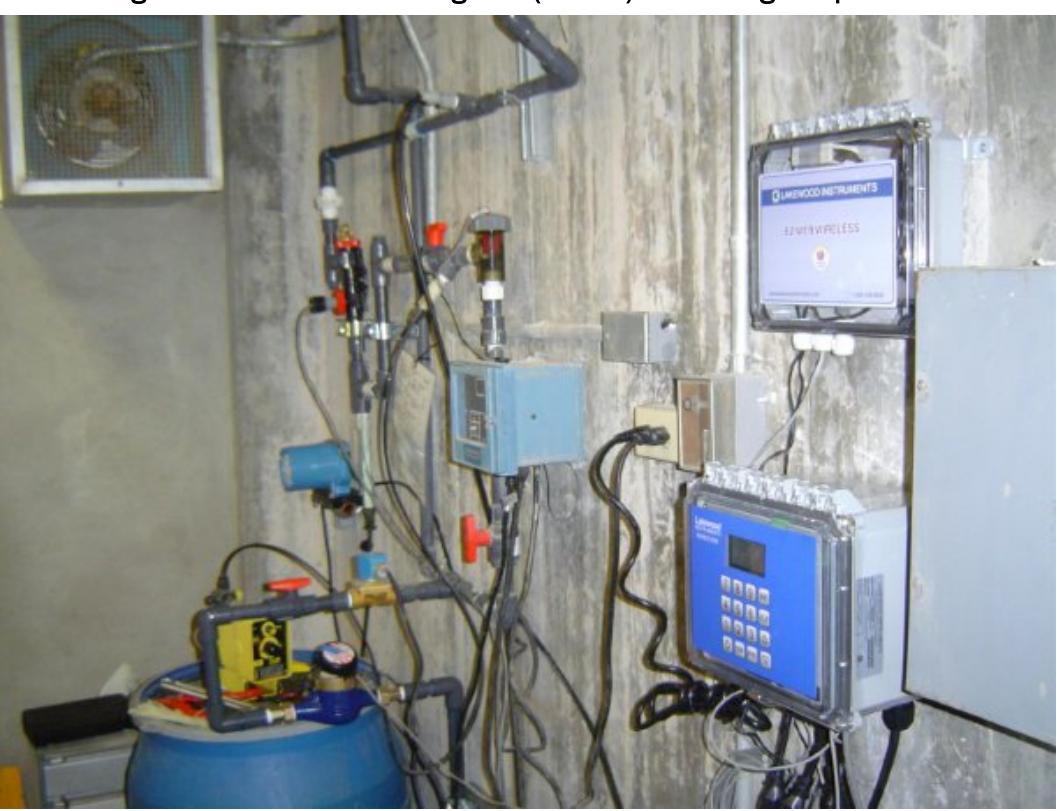
Figure 16. Fort Irwin Building 263 (control) monitoring components.

The same monitoring instrumentation was installed at this location as in Building 263 (Figure 16). No Zeta Rods were installed, so no welding was required at this site. The existing conductivity controller was left in place at its existing settings. This controller continued to control the blowdown solenoid valve for the cooling tower at this location. The watermanagement system collected data from the conductivity probe, the corrosion probe and the two water meters.

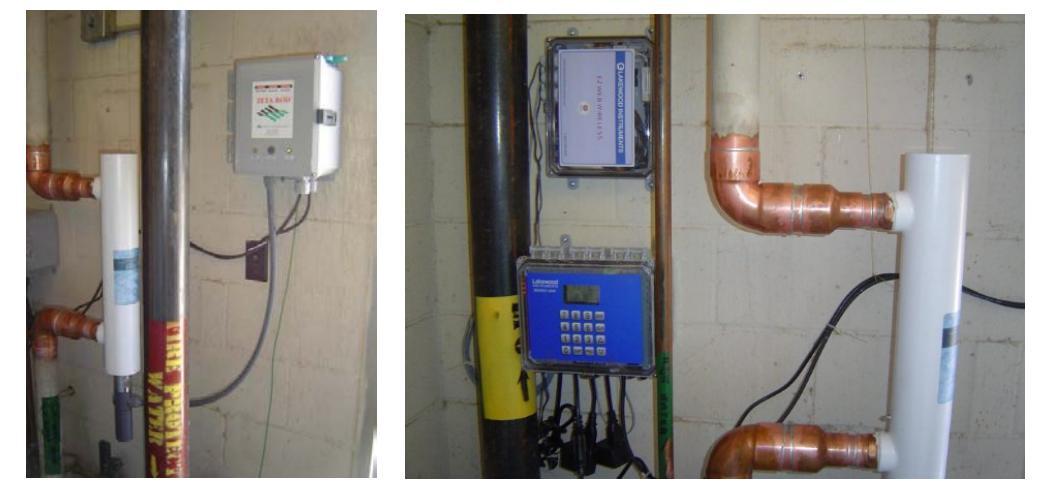
Figure 17. Fort Irwin Building 873 application installed on the 3 in. main water line (left), and with controller/data-logger and wireless communications hardware (right).

A controller/data logger unit was installed in the mechanical room (Figure 17) and set to continuously monitor the high-voltage output of the power supply through a 4 - 20 mA circuit and programmed to send an alarm if the signal dropped below 10 mA.

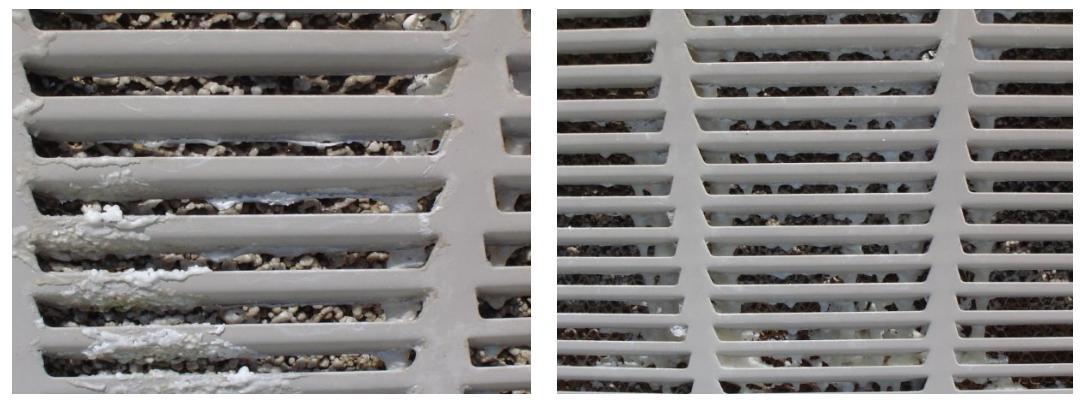
Figure 19. Mineral accumulation on swamp cooler pads (left) and cooler frames (right) at startup at Fort Irwin Building 873 Zeta application.

Most of the coolers at this location, as shown in Figure 19, had heavy mineral buildup and accumulation both on the pads and the external frame of the units.

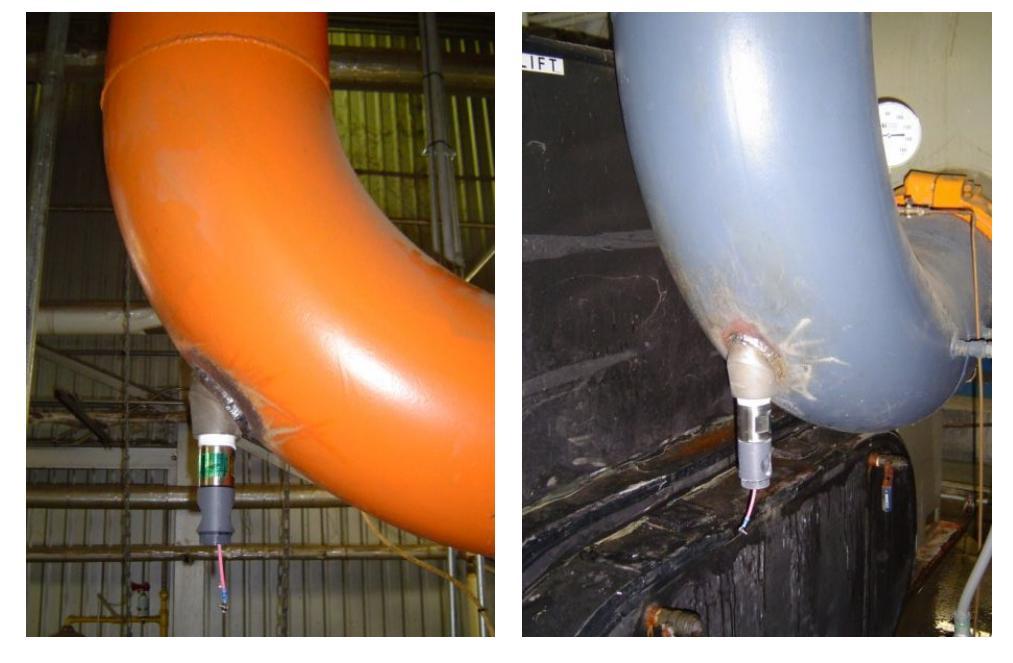
Figure 20. Capacitor rods are mounted on 1.5 in. thread-o-let fitting in CWR and CWS lines at Warner Robins chiller #2.

To install the capacitor rods it was necessary to weld a 1.5 in. thread-o-let mild steel fitting at elbows in the pipes. Figure 20 shows the thread-o-lets with the capacitor rods inserted into the CWS and CWR pipes to each one of the two chillers in the plant.

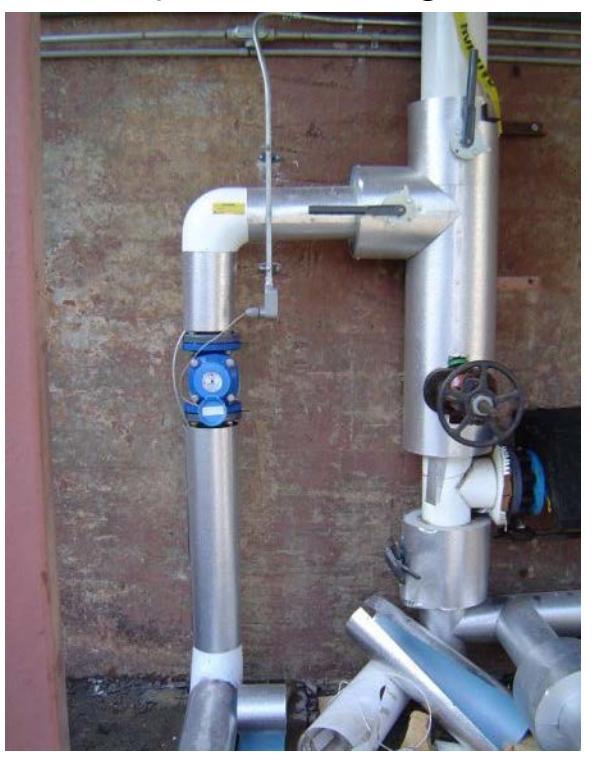
Figure 21. Three-inch water meter in makeup water line for cooling tower 2.

Conventional plumbing practices were used for the installation of the 3 in. makeup water meters and 0.75 in. blowdown water meters. Figure 21 shows the water meter on the makeup water line for cooling tower 2.

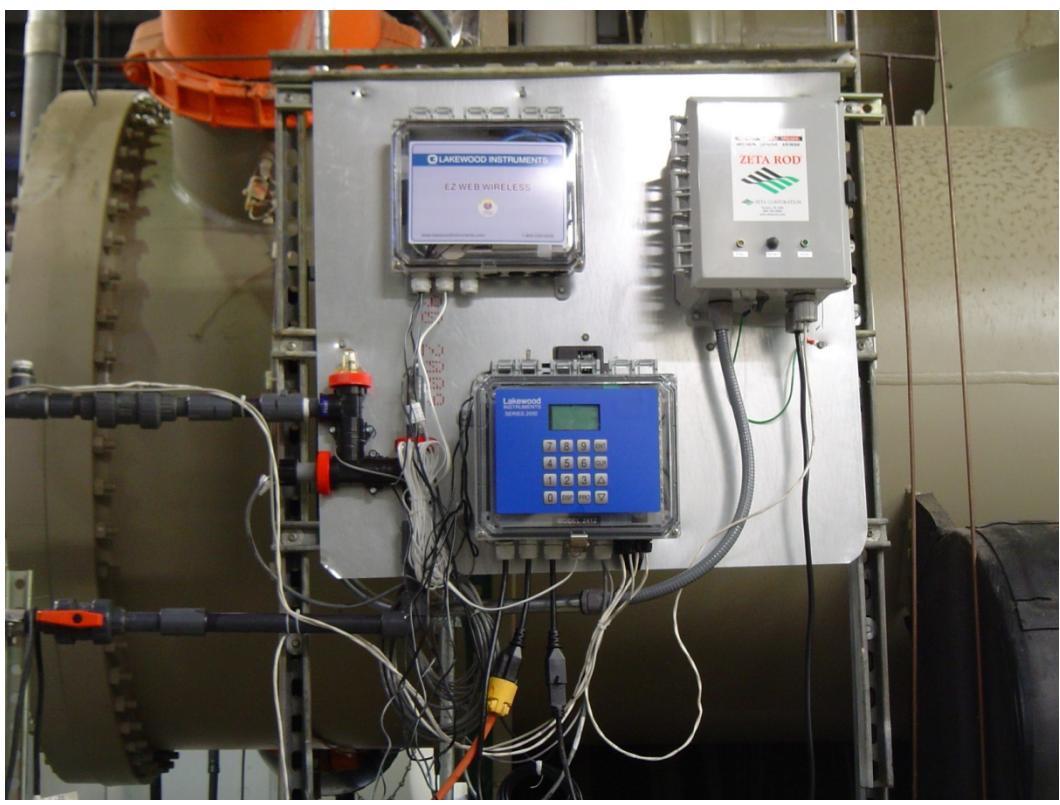
Figure 22. Water-management system components.

Figure 22 shows all the hardware used in the water-management system on chiller 2.

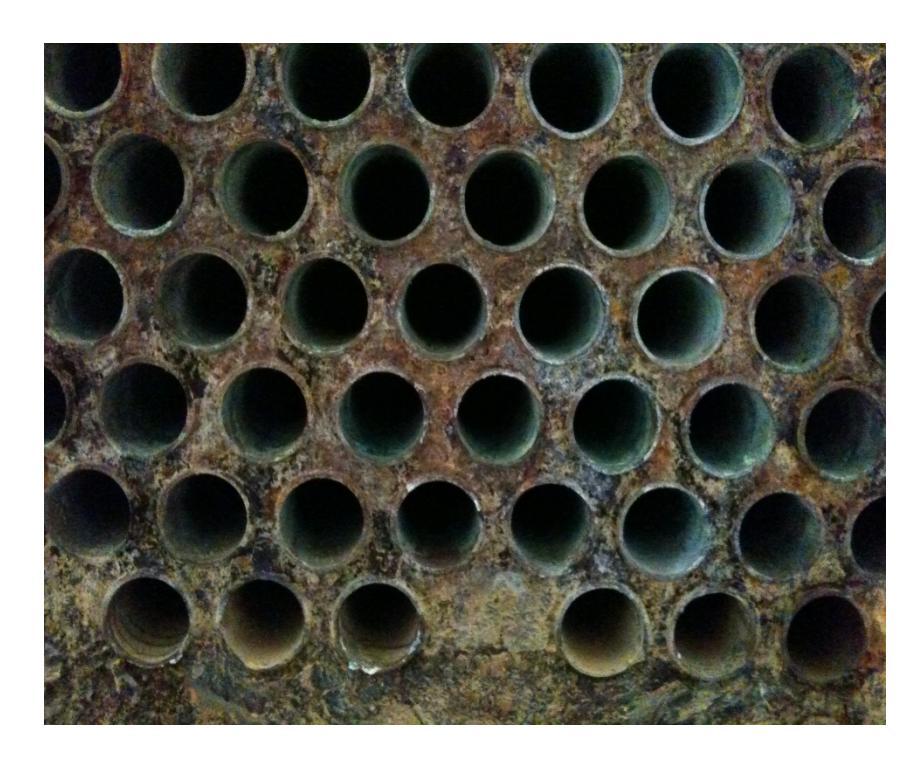
Feb 1st, 2010: Baseline inspection at Fort Irwin, Bldg 263 (Zeta) condenser tube sheet. Notice scale layer on surface of the 2^{nd} and 4^{th} tube of the lowest row.

Tubes showed some improvement in condition over the period of the Dem/Val. The following pictures show the condition of the tube sheet during the three inspections. During the Feb 2010 inspection, a light layer of scale could be seen on the surface of the tubes in the lowest row. The same tubes showed no visible scale deposits by the Jan 2011 inspection.

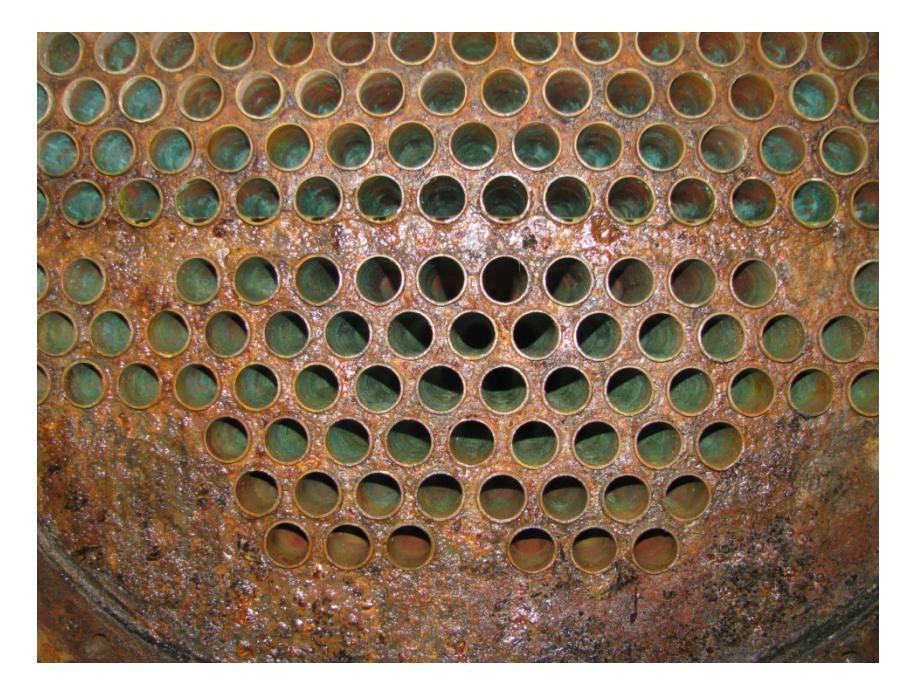
January 6, 2011: Fort Irwin, Bldg 263 (Zeta) condenser tube sheet. The layer of scale previously seen on the 2nd & 4th tubes of the lower row is no longer present. No cleaning (mechanical or chemical) took place between the two inspections.

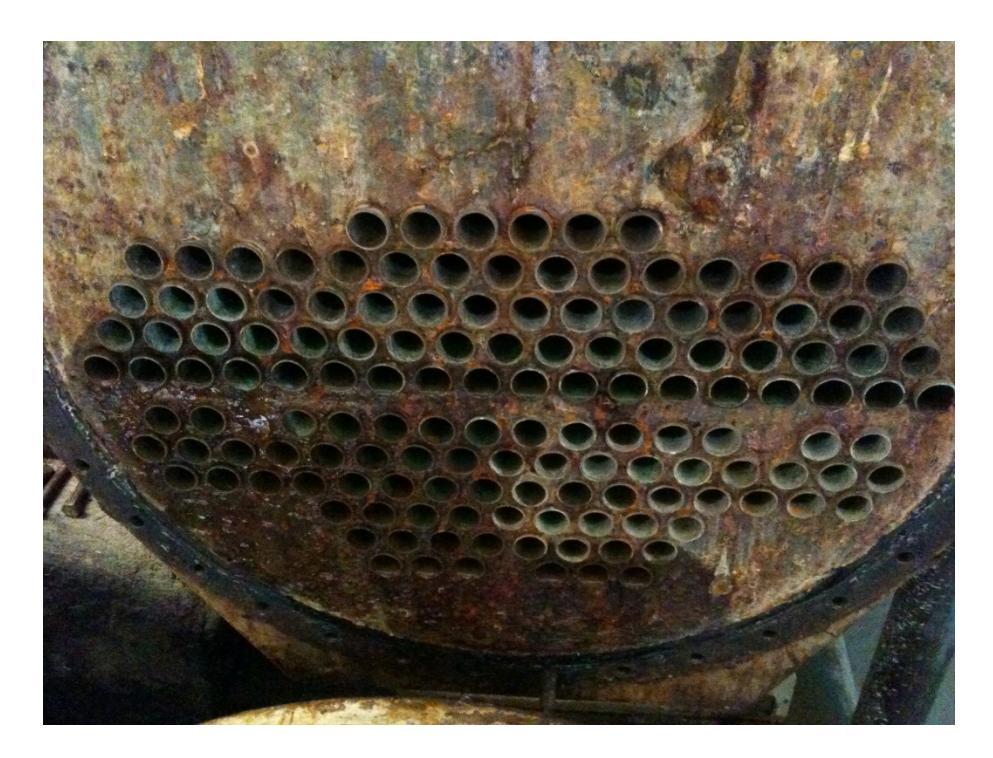
December 12, 2011: Fort Irwin Bldg 263 (Zeta) condenser tube sheet showing no visible signs of scale on any of the tubes or the tube sheet after operating for two years without any chemical treatment.

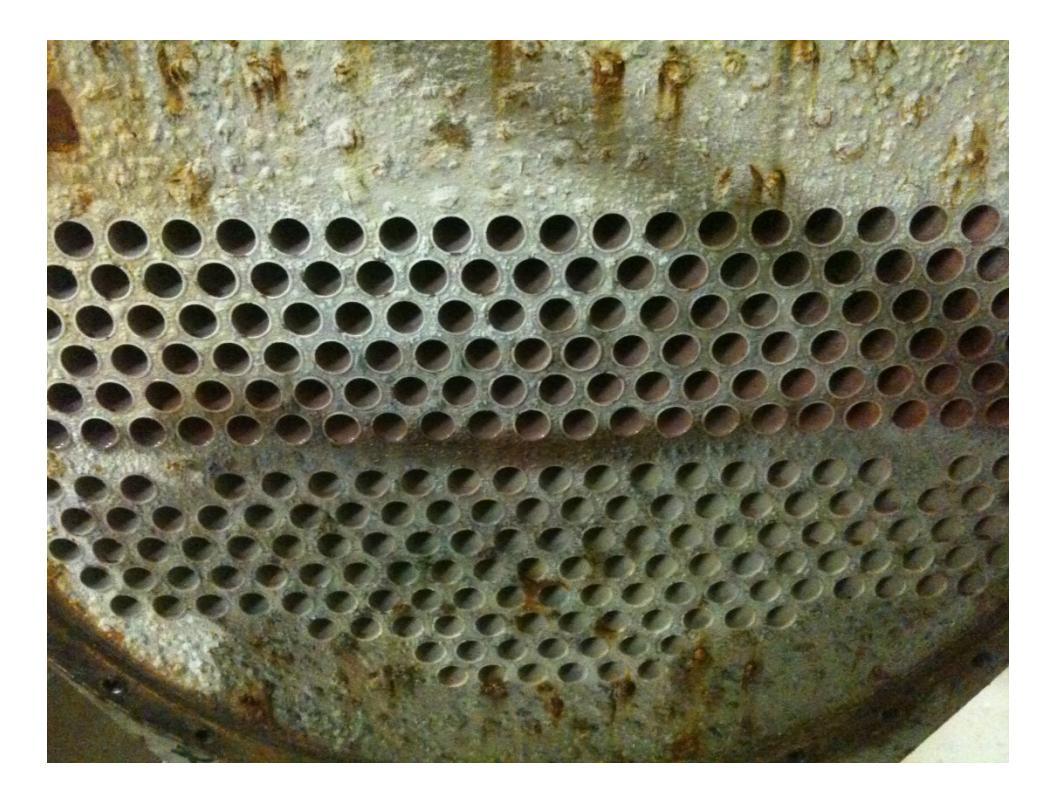
February 2, 2010: Fort Irwin Bldg 273 (Control) – scale visible on tube surfaces. Thicker layer on bottom tubes (second pass) than on the top half tubes (first pass).

Upon the initial inspection the tubes in the condenser showed a visible layer of scale on all tube surfaces, indicating scaling of the tubes. Over the course of the evaluation, the condition of the tubes worsened. Scale on some sections of tubes was scraped off to determine whether new scale would form on the tubes, or to determine if the scale present during the first inspection was old scale and it was being controlled. In the two following inspections, the cleaned sections of tubes had scaled over.

This cooling tower had problems with the chemical delivery system on a couple of occasions between inspections. During these periods the chemical control tower operated with no chemicals and the condenser tubes scaled over. This provides valuable information, for it validates that the Zeta treatment used at Fort Irwin was capable of preventing scale formation on the treated chiller after two years of operation without any chemicals; whereas the control system developed scale while operating at lower cycles of concentration and using the same water during two short periods of time in which chemicals were not fed to the tower.

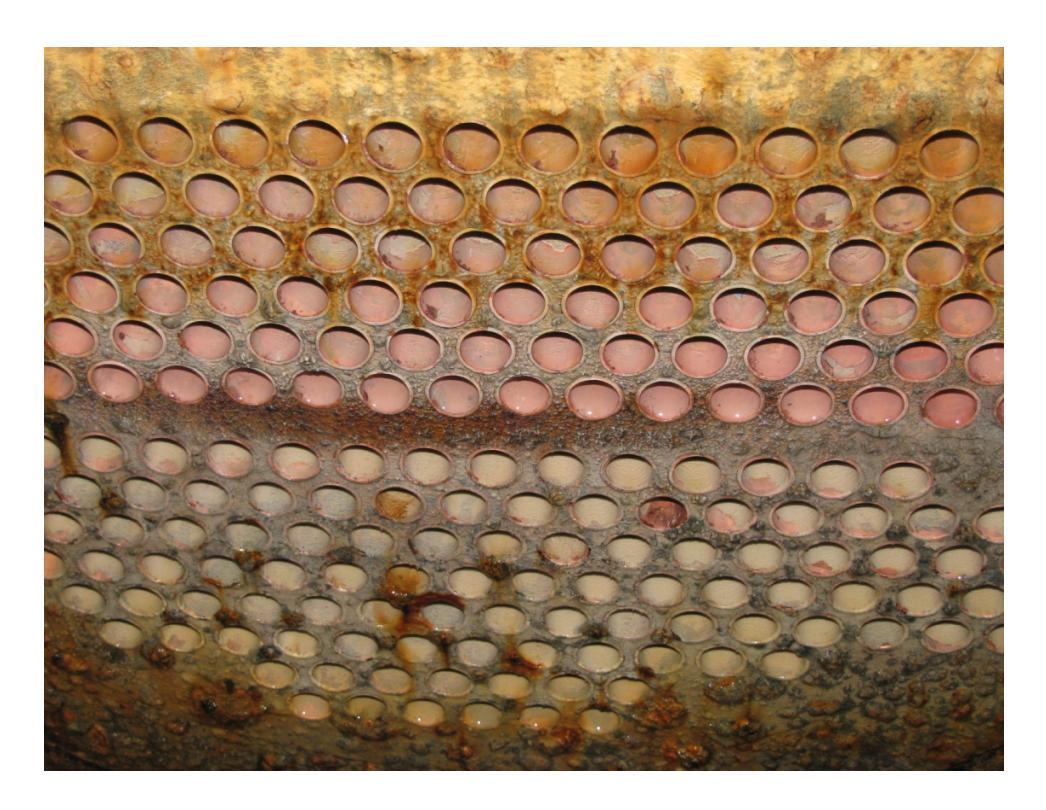
January 6, 2011: Fort Irwin Bldg 273 (Control) – Scale still present on tubes. This picture was taken after the tubes had been brushed clean.

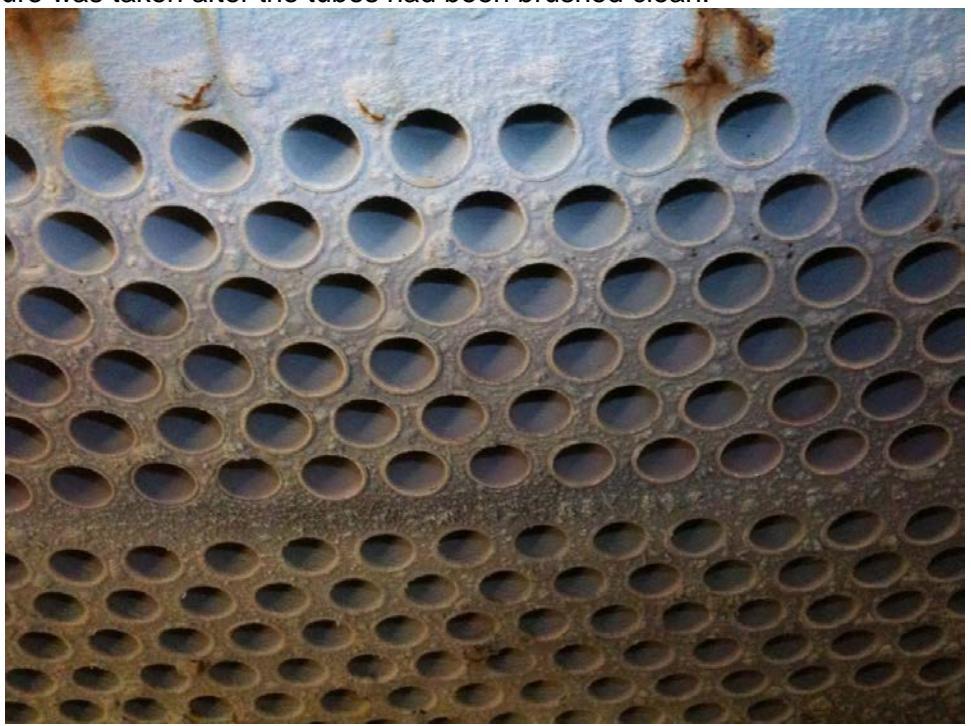
December 12, 2011: Fort Irwin Bldg 273 (Control) – A heavier layer of scale is now seen on all tubes both on the first pass and second pass, as well as on the tube sheet itself.

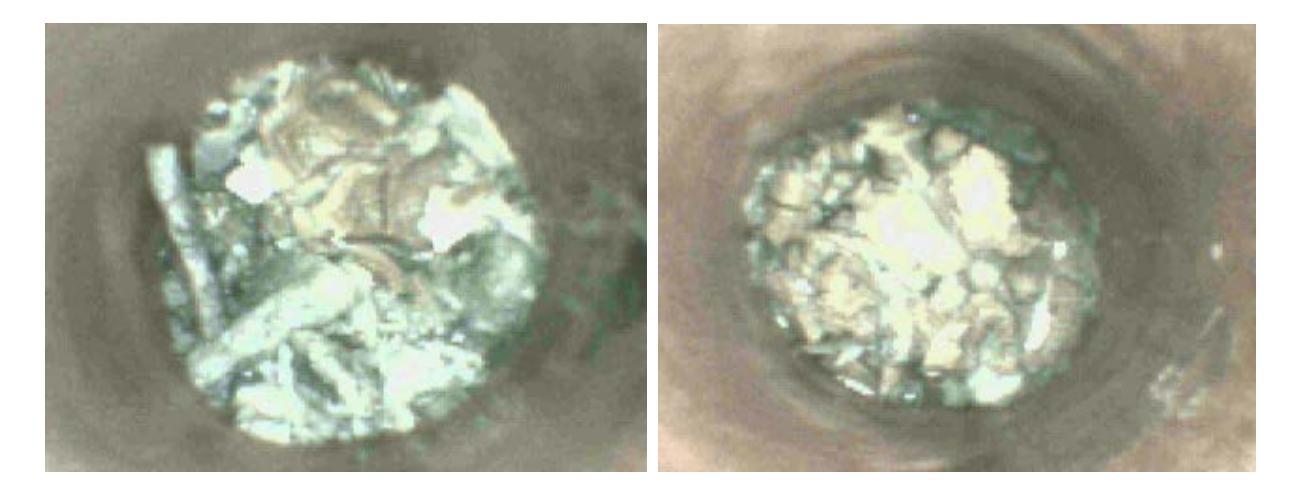
When the decommissioned chiller was opened, some tubes showed severe fouling. These were the same tubes that had been identified as being partially blocked during a previous inspection one year earlier. The tubes had not been cleaned as recommended, and the chiller was allowed to operate in that manner. Further inspection showed that only those tubes with debris plugs had severe fouling. This is not an indication of the water treatment program not performing, but rather a maintenance issue of the cooling tower basin. The following pictures show the detail of the plugs formed on the front-end (water in) side of the tubes of the decommissioned chiller.

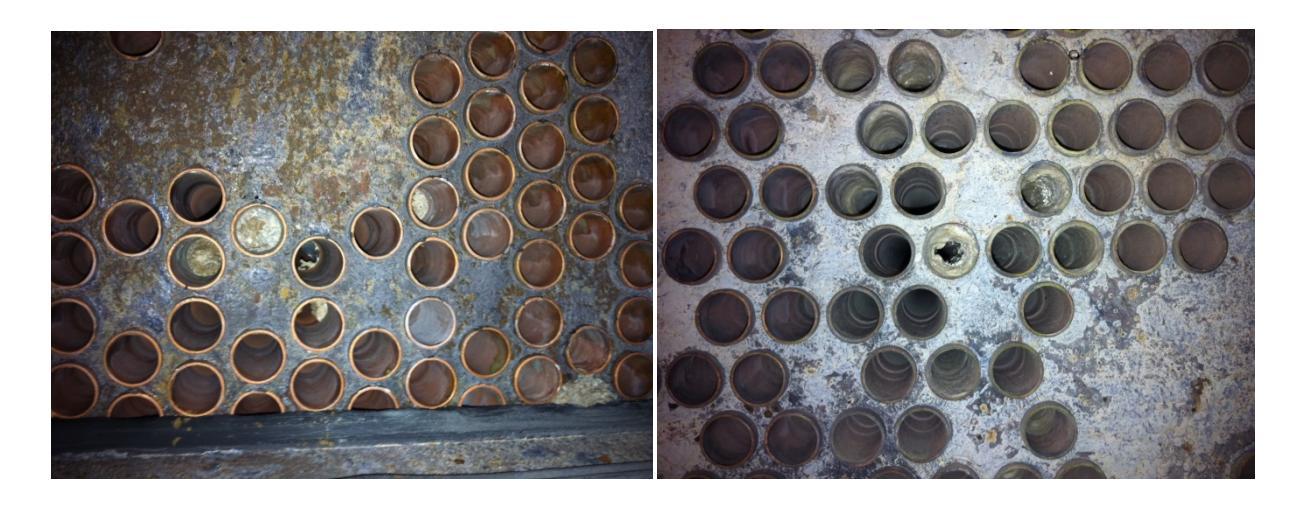
The next two pictures show the tube sheet's condenser water supply side (left) and condenser water return side (right). As can be seen on the supply side, the tube surfaces prior to the blockage show a clean copper surface. The return side shows the severe fouling on the blocked tube surfaces. This is a result of the no flow zone created in the tube that leads to a high temperature area. This combination permitted scale formation in the affected tubes.

If this had been a result of bulk scale formation, then all the tubes would have shown an even layer of scale.

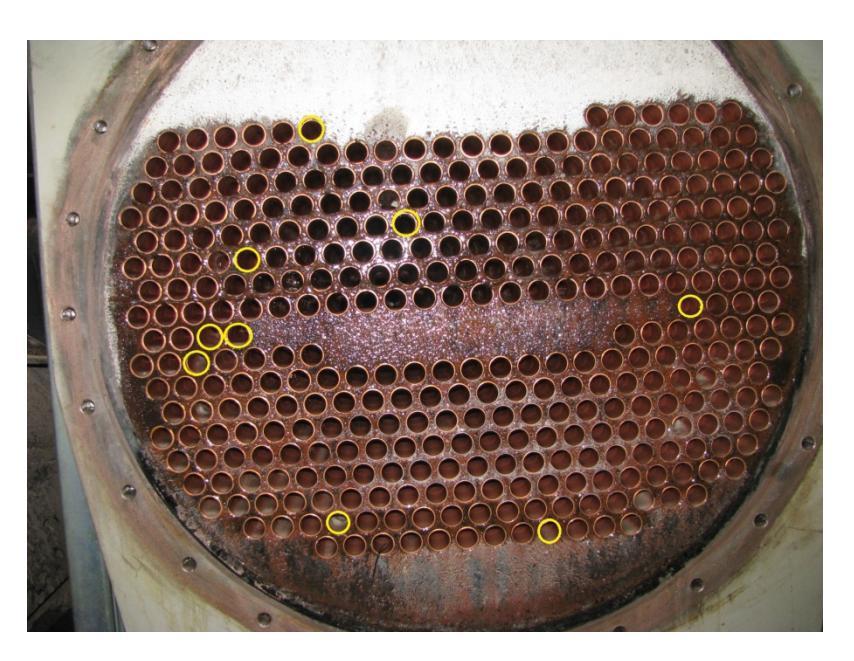
January 10, 2011: Upon opening of the condenser, the first thing that was noticed were several tubes showing debris blockage similar to what had been observed in the decommissioned chiller in the SCP during the Feb 2010 inspection. In general, the non-affected tubes showed no scale deposition, however, some of the affected tubes were starting to show signs of scale buildup. Tubes were cleaned prior to restarting the chiller.

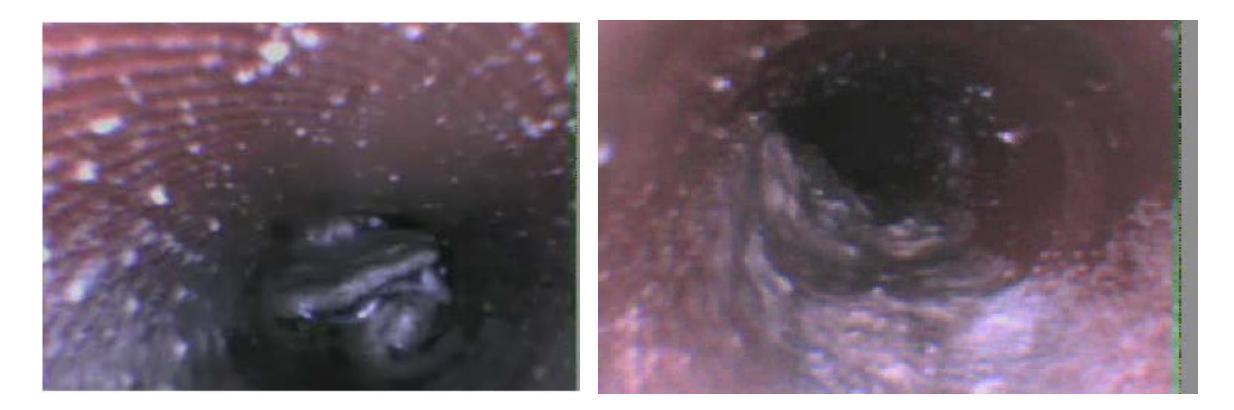
January 10, 2011: Fort Huachuca NCP (Control) debris blockage in some of the tubes.

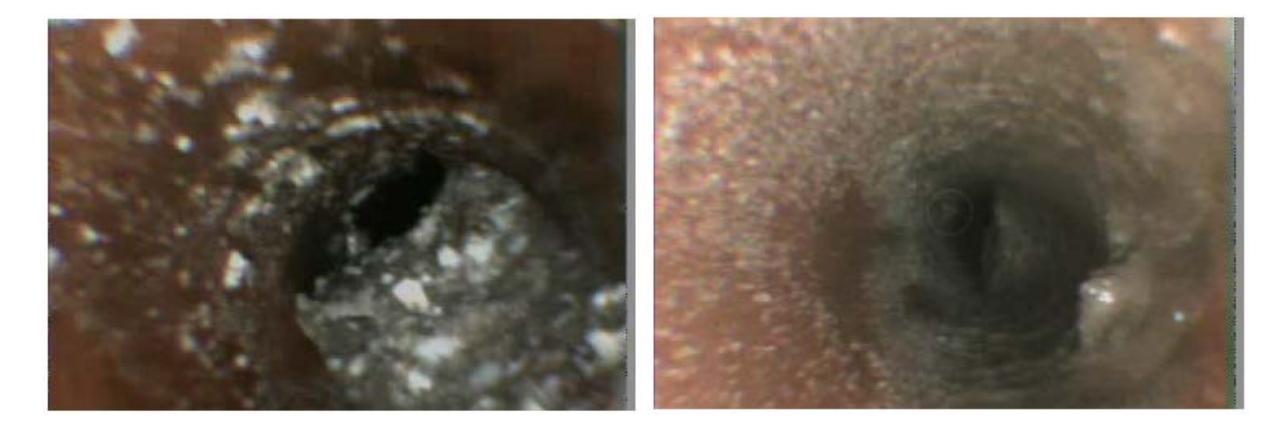
November 18, 2011: Once again several tubes (different tubes from the previous inspection) showed signs of debris accumulation and blockage.

November 18 2011: Fort Huachuca NCP (Control) debris blockage and sediment accumulation in some of the tubes.

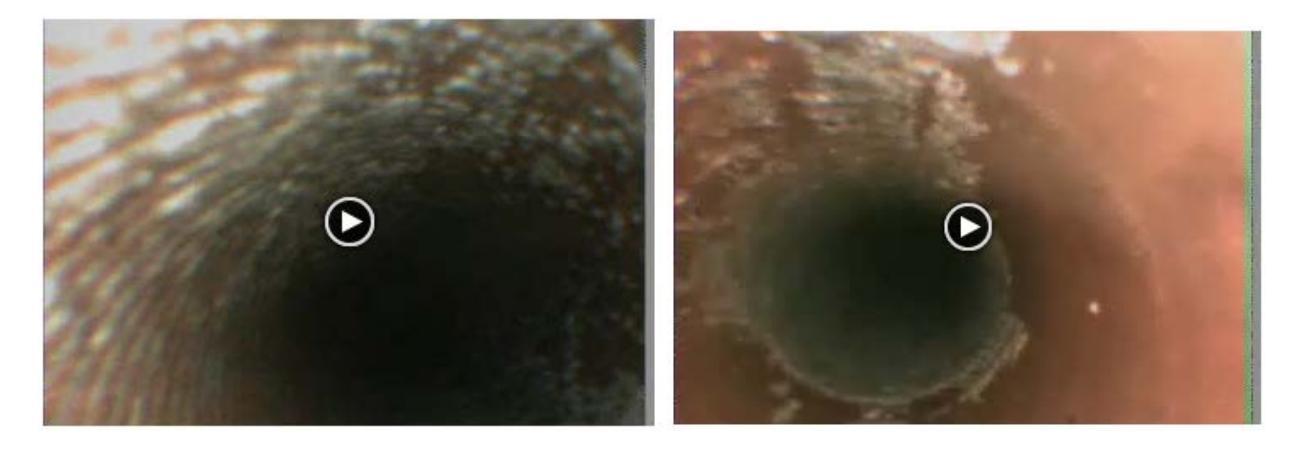
November 18, 2011: Fort Huachuca NCP (Control) frame grabs from video files showing scale starting to form on some of the affected tubes.

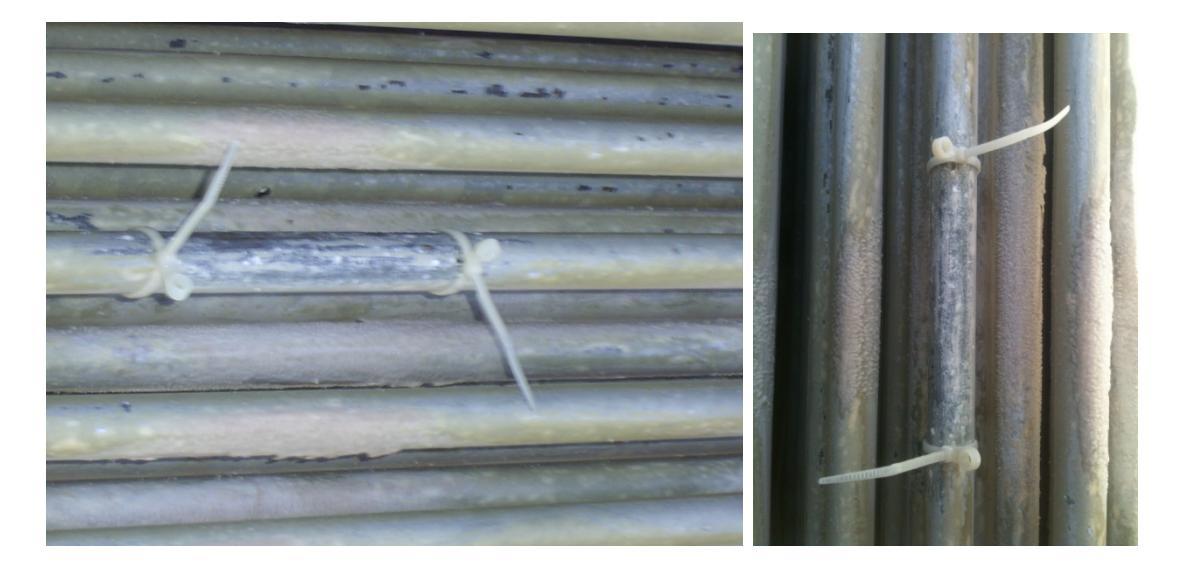
August 17, 2009. December 15, 2009

Over the 4 years in which the evaporative condenser was evaluated, no noticeable amount of scale was formed on the clean tube surfaces as seen in the following pictures:
