Demonstration of Noncorrosive, Capacitance-Based Water-Treatment Technology for Chilled-Water Cooling Systems

Final Report on Project F09-AR08

September 2014

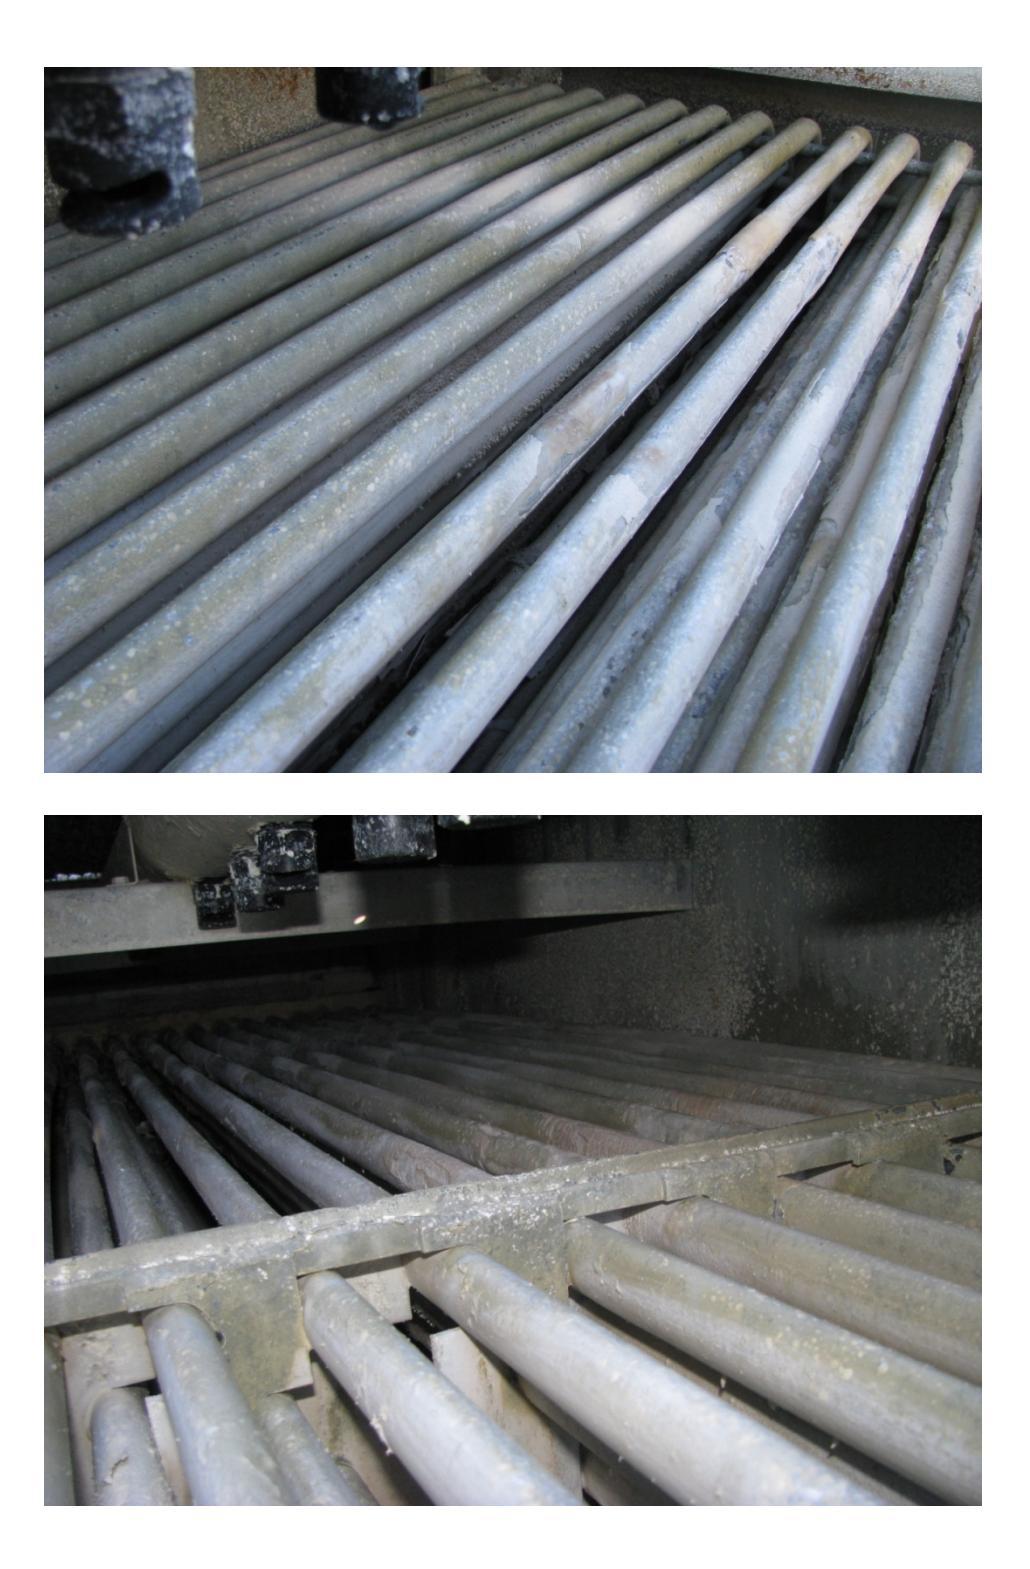
The following pictures show the general condition of the tubes in the evaporative condenser on February 28, 2011. This unit had been operating since the summer of 2007 without the use of any chemicals.
